August 28, 2024

C.C. (Chris) Andersen  
**Central Adjustment Company, Inc.**  
Post Office Box 25068  
Little Rock, Arkansas 72221

RE: File No: **173616**  
Insured: 198 Northwest Arkansas Community College  
Address: One College Drive  
Bentonville, Arkansas 72712  
Date of Loss: May 26, 2024  
BSC File No: 240353.S-01-1

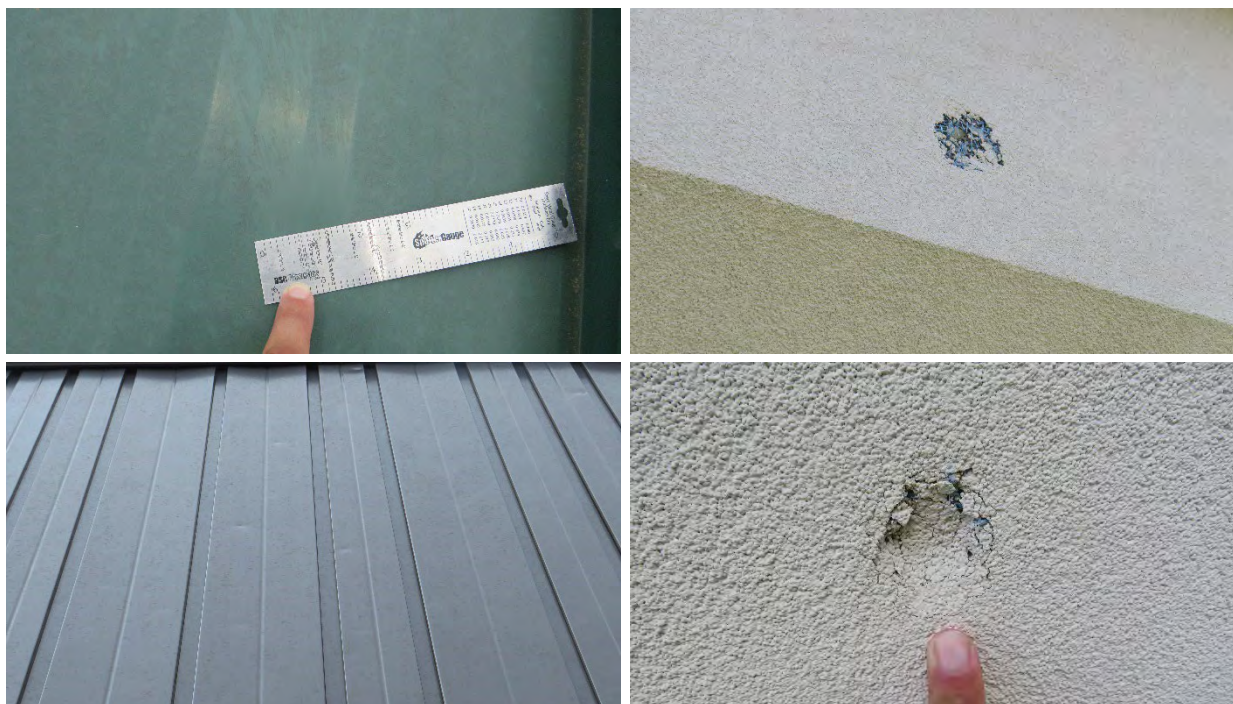
**The Campus (Date of Loss):** BSC’s inspection revealed evidence of hailfall in the form of spatter marks up to approximately 1-3/4 inches wide (golf ball-sized) indicative of hailfall from the north-northwest. The evidence was consistent with the documented hail event in the vicinity of the subject property on or about the reported date of loss. Generally, hail-related distress conditions were isolated to the north-facing elevations on the various structures. Distress conditions along the various elevations associated with the reported event are detailed in the *Rough-Order Scope* section(s) herein. It is BSC’s professional opinion that evidence of hailfall associated with the reported date of loss was documented at the subject property in the form of patterned spatter marks up to 1-3/4 inches wide (golf ball-sized) indicative of hailfall from the north-northwest.

Figure 1. Vulnerable elements with evidence of hailfall consistent with the reported date of loss.

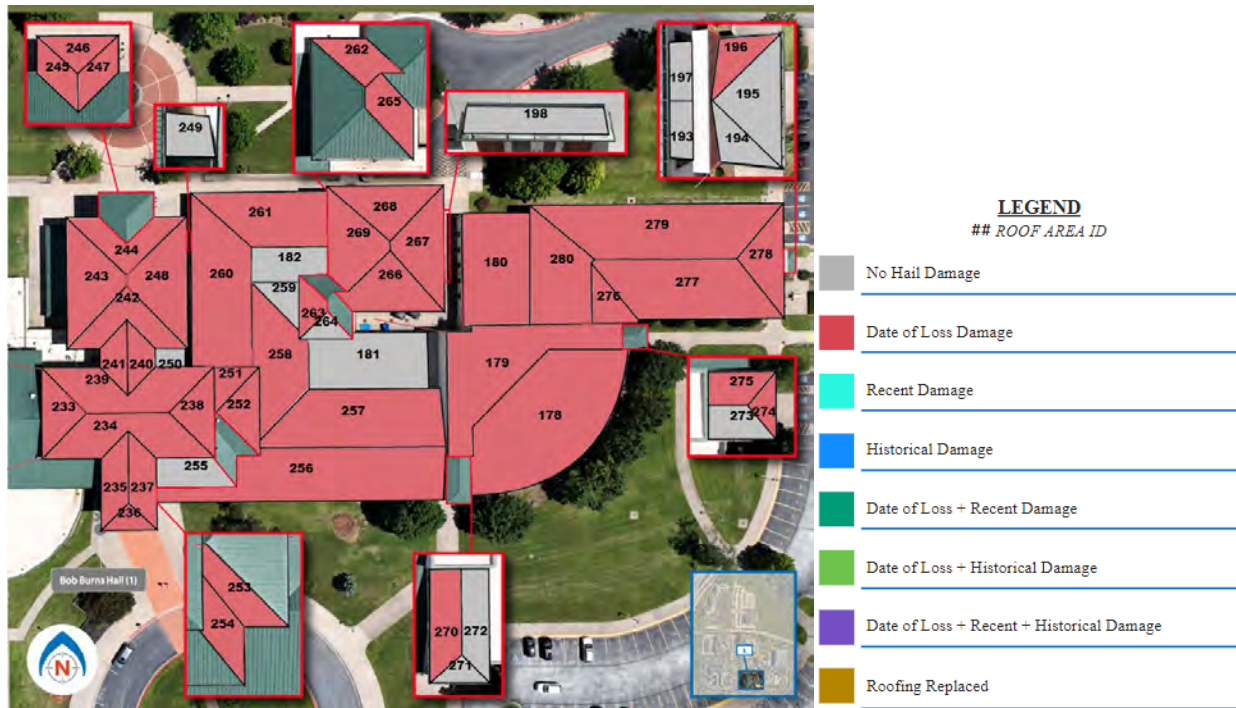
Figure 3. Excerpt of SAM Q-PDF® that depicts the locations and relative date(s) of occurrence of hail-related conditions to the roofing, by color.

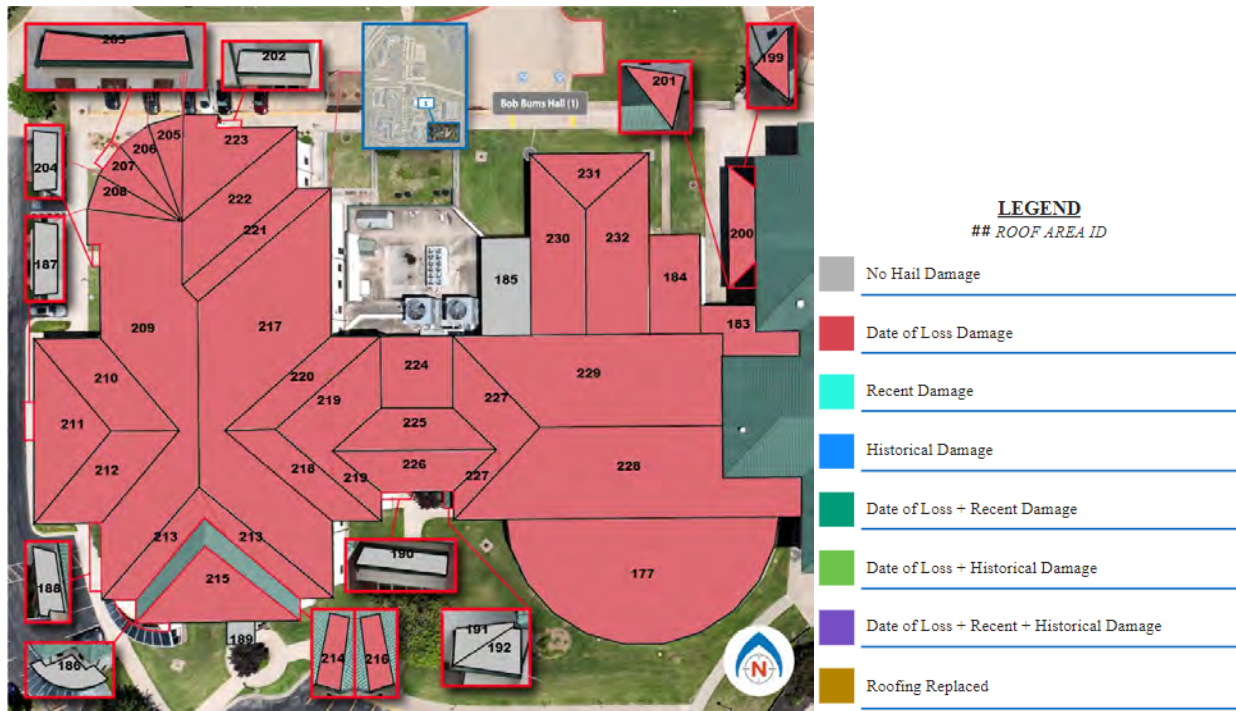
Figure 4. Excerpt of SAM Q-PDF® that depicts the locations and relative date(s) of occurrence of hail-related conditions to the roofing, by color.

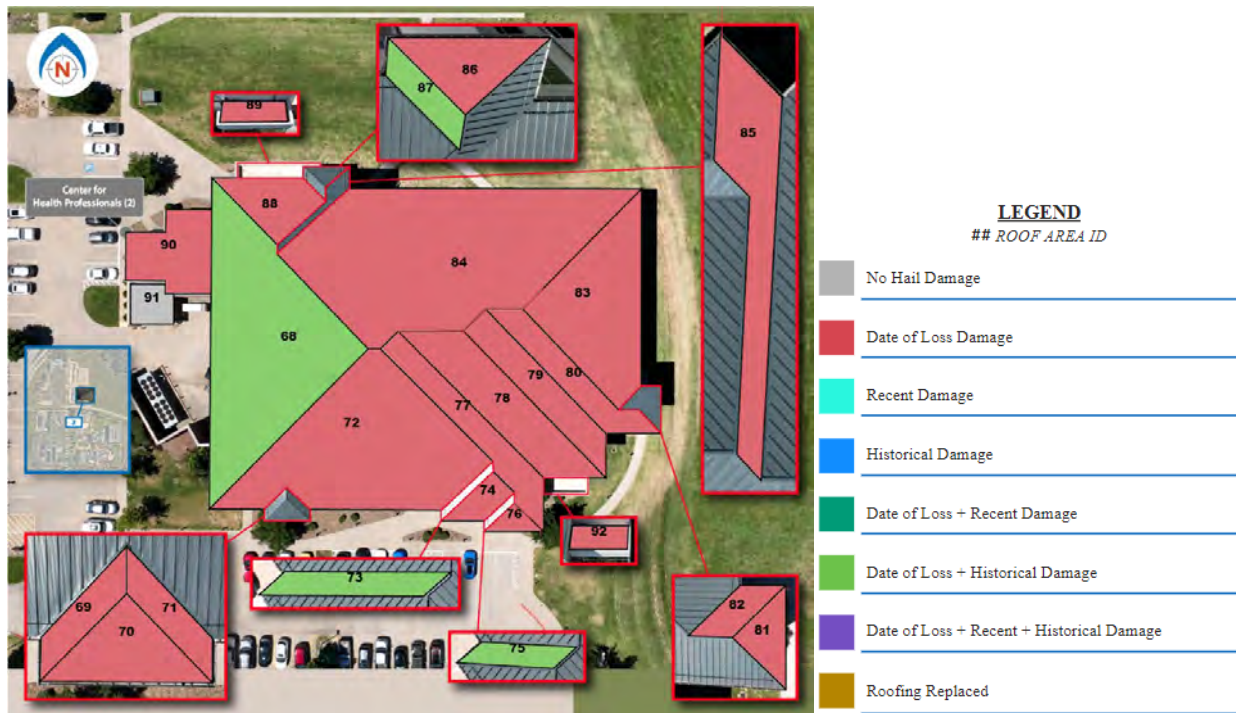
Figure 5. Excerpt of SAM Q-PDF® that depicts the locations and relative date(s) of occurrence of hail-related conditions to the roofing, by color.

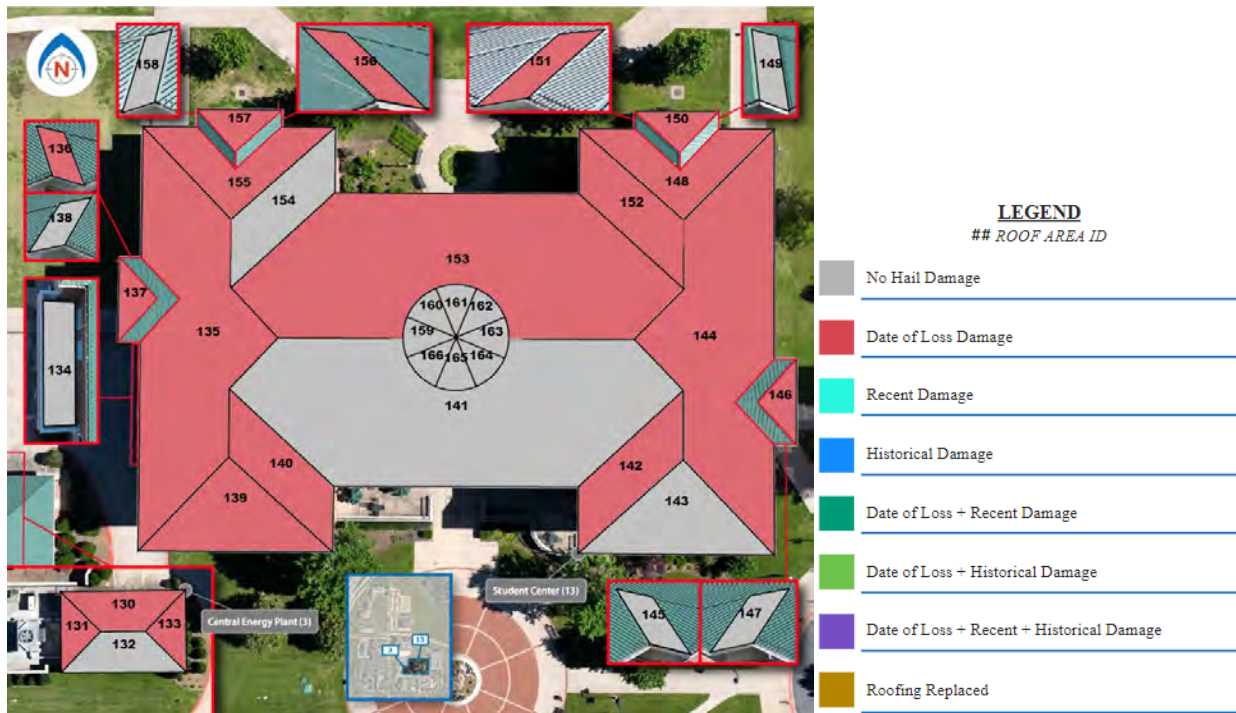
Figure 6. Excerpt of SAM Q-PDF<sup>®</sup> that depicts the locations and relative date(s) of occurrence of hail-related conditions to the roofing, by color.

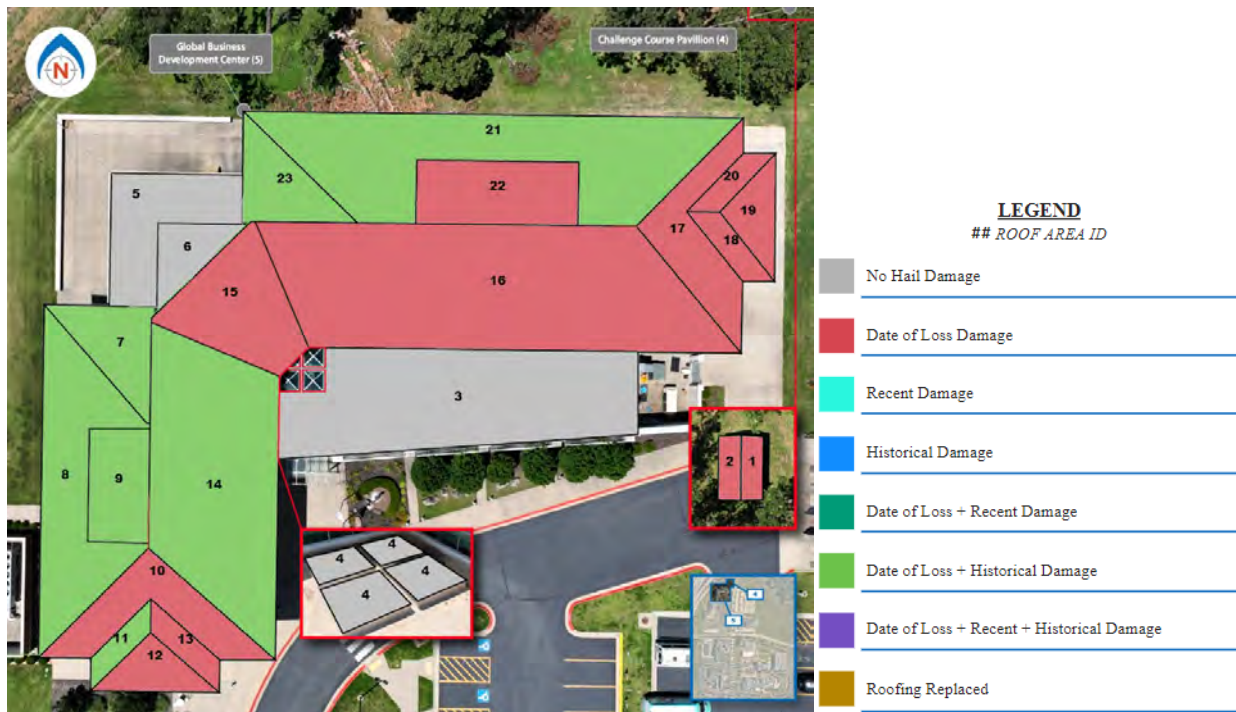
Figure 7. Excerpt of SAM Q-PDF<sup>®</sup> that depicts the locations and relative date(s) of occurrence of hail-related conditions to the roofing, by color.

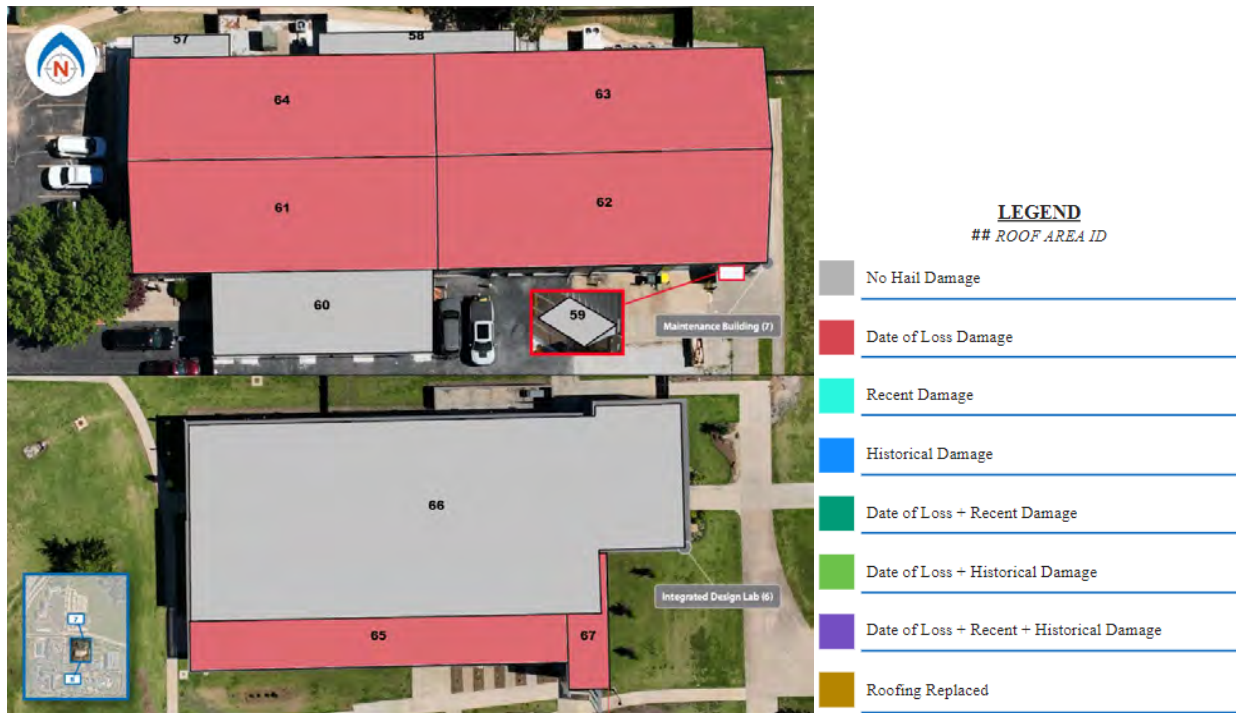
Figure 8. Excerpt of SAM Q-PDF® that depicts the locations and relative date(s) of occurrence of hail-related conditions to the roofing, by color.

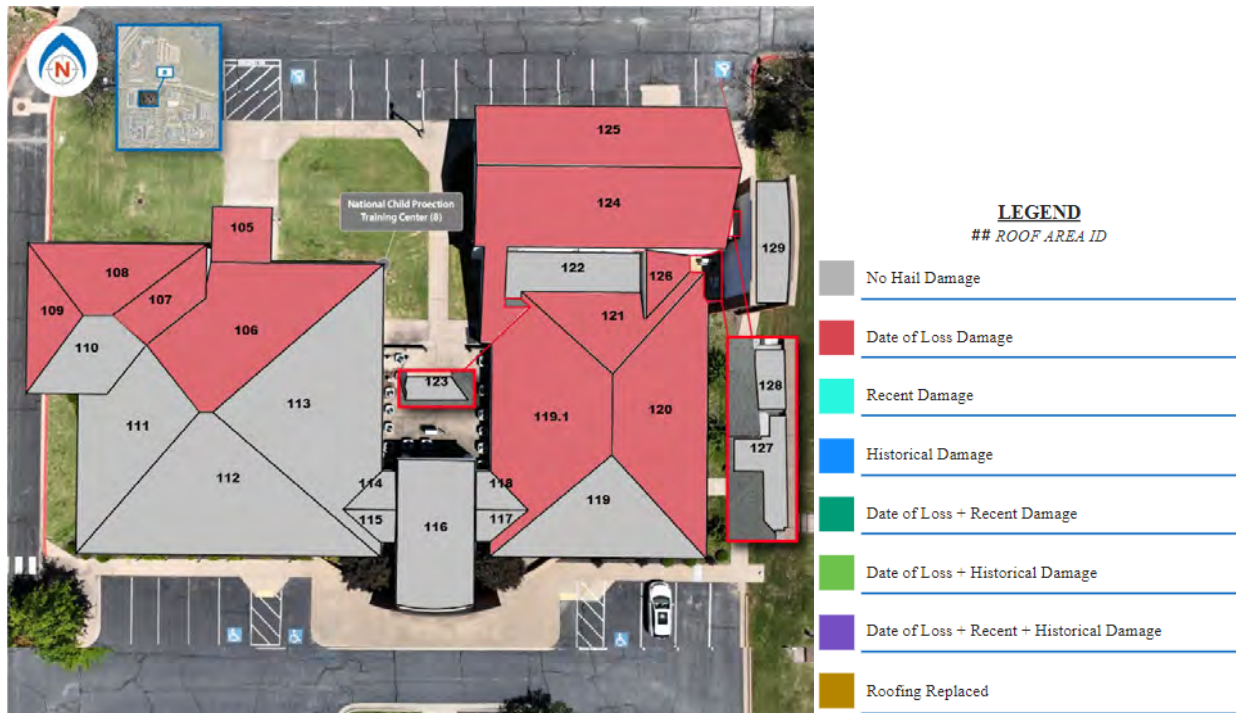
Figure 9. Excerpt of SAM Q-PDF® that depicts the locations and relative date(s) of occurrence of hail-related conditions to the roofing, by color.

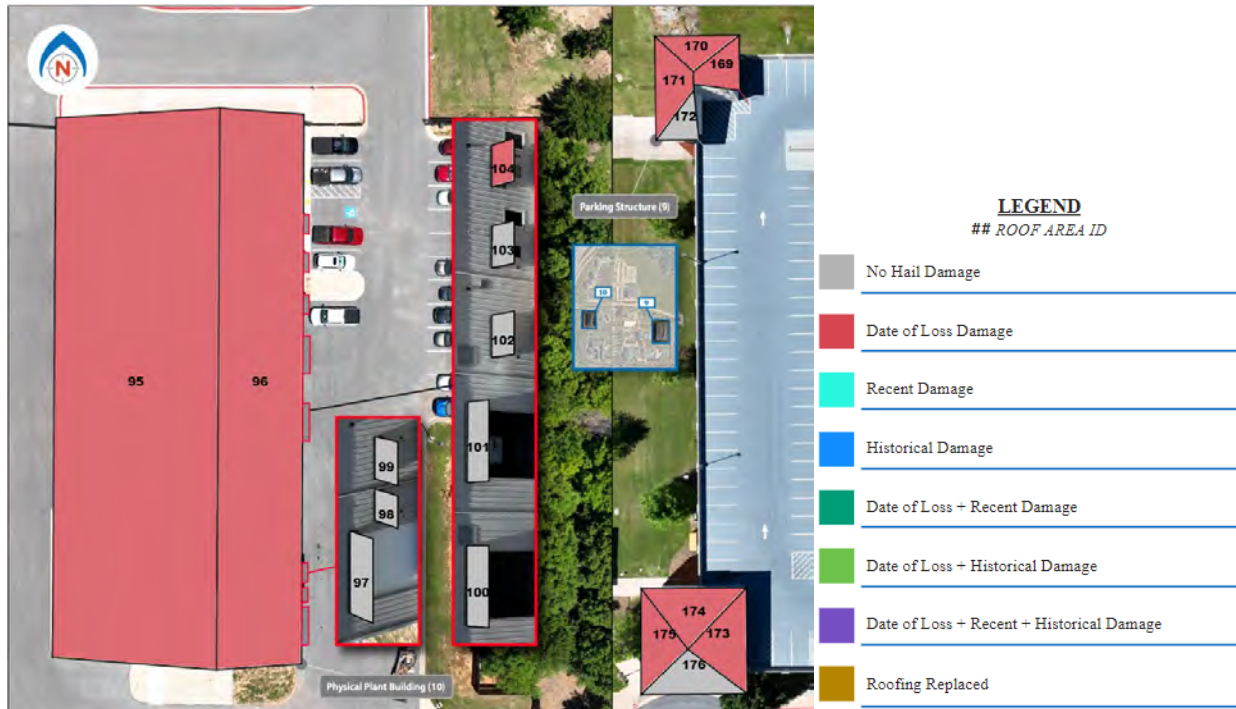
Figure 10. Excerpt of SAM Q-PDF<sup>®</sup> that depicts the locations and relative date(s) of occurrence of hail-related conditions to the roofing, by color.

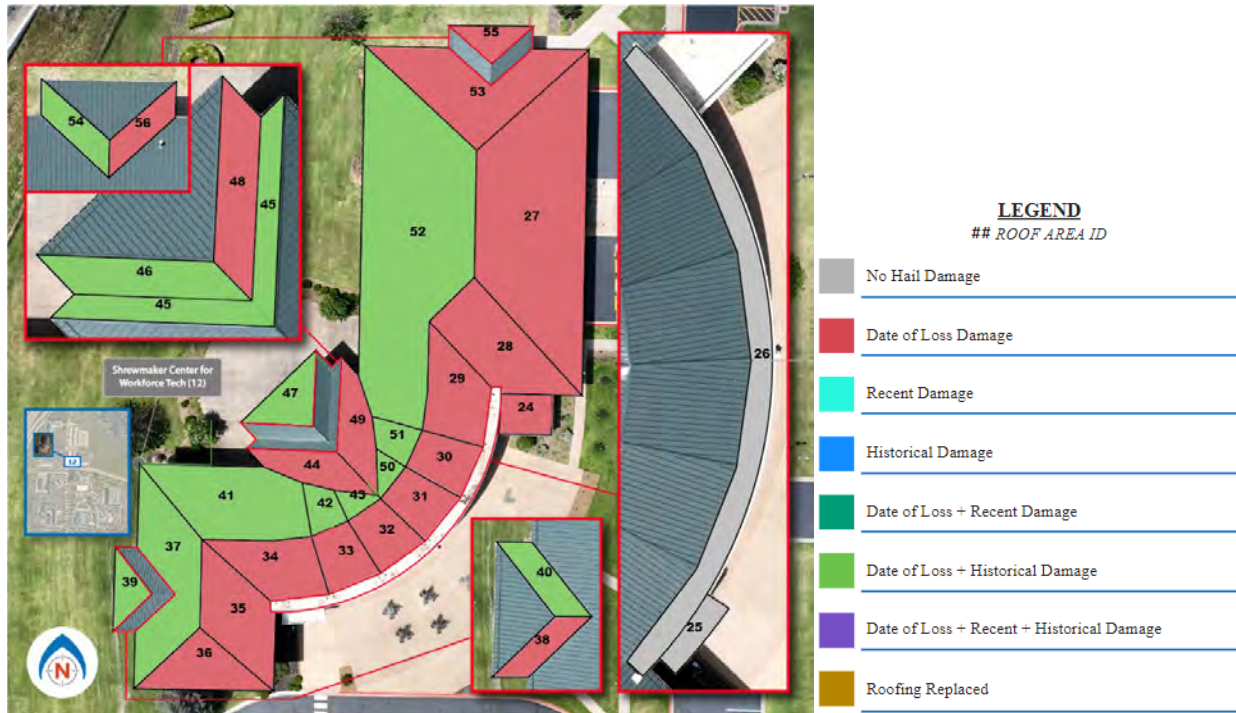
Figure 11. Excerpt of SAM Q-PDF<sup>®</sup> that depicts the locations and relative date(s) of occurrence of hail-related conditions to the roofing, by color.

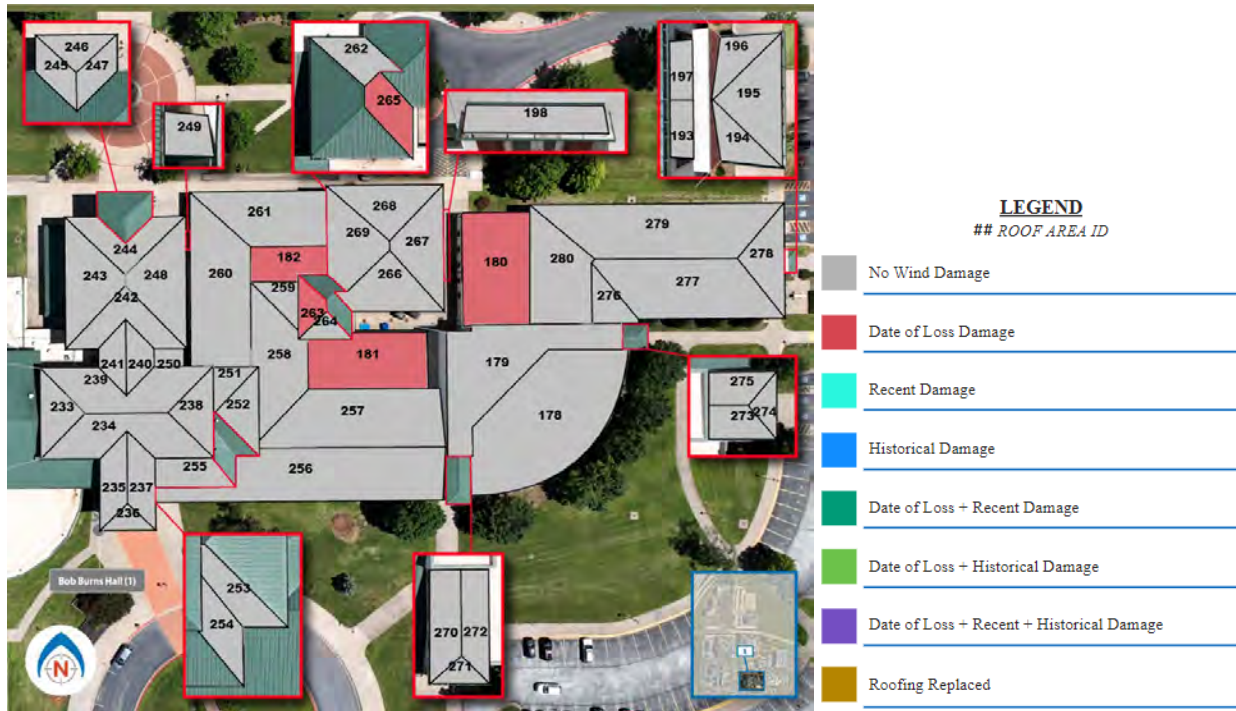
Figure 56. Excerpt of SAM Q-PDF® that depicts the locations and relative date(s) of occurrence of wind-related conditions to the roofing, by color.

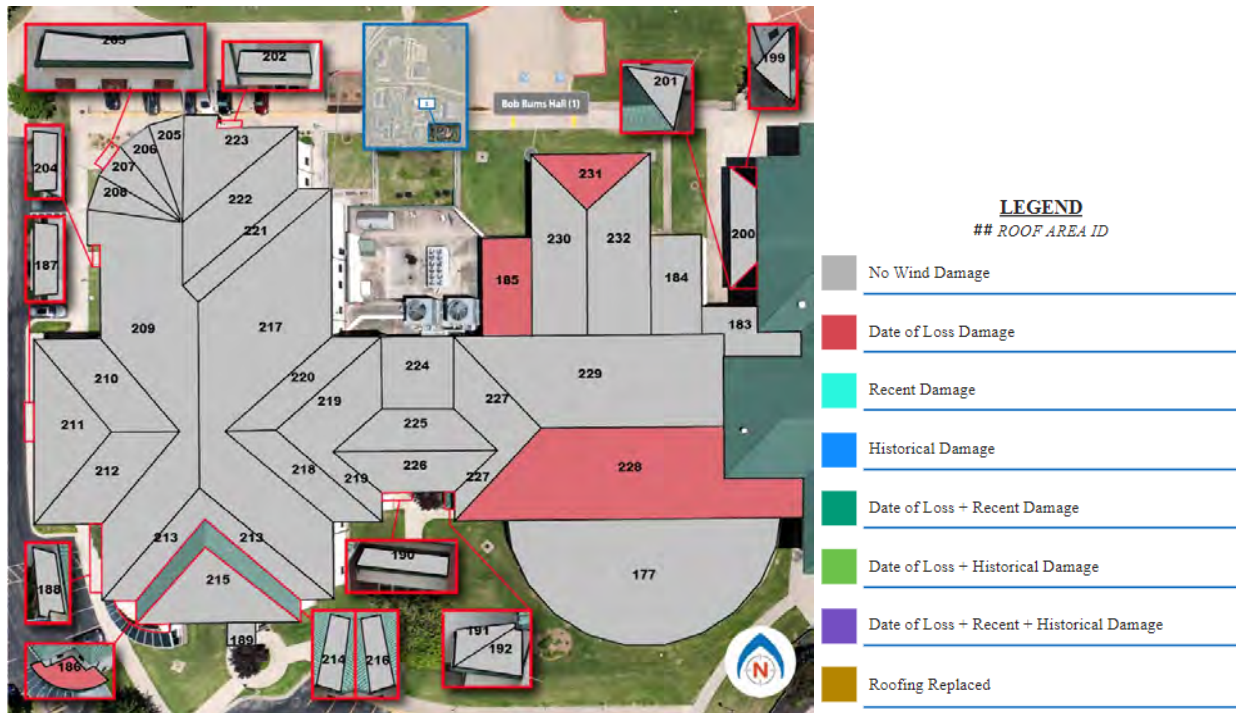
Figure 57. Excerpt of SAM Q-PDF® that depicts the locations and relative date(s) of occurrence of wind-related conditions to the roofing, by color.

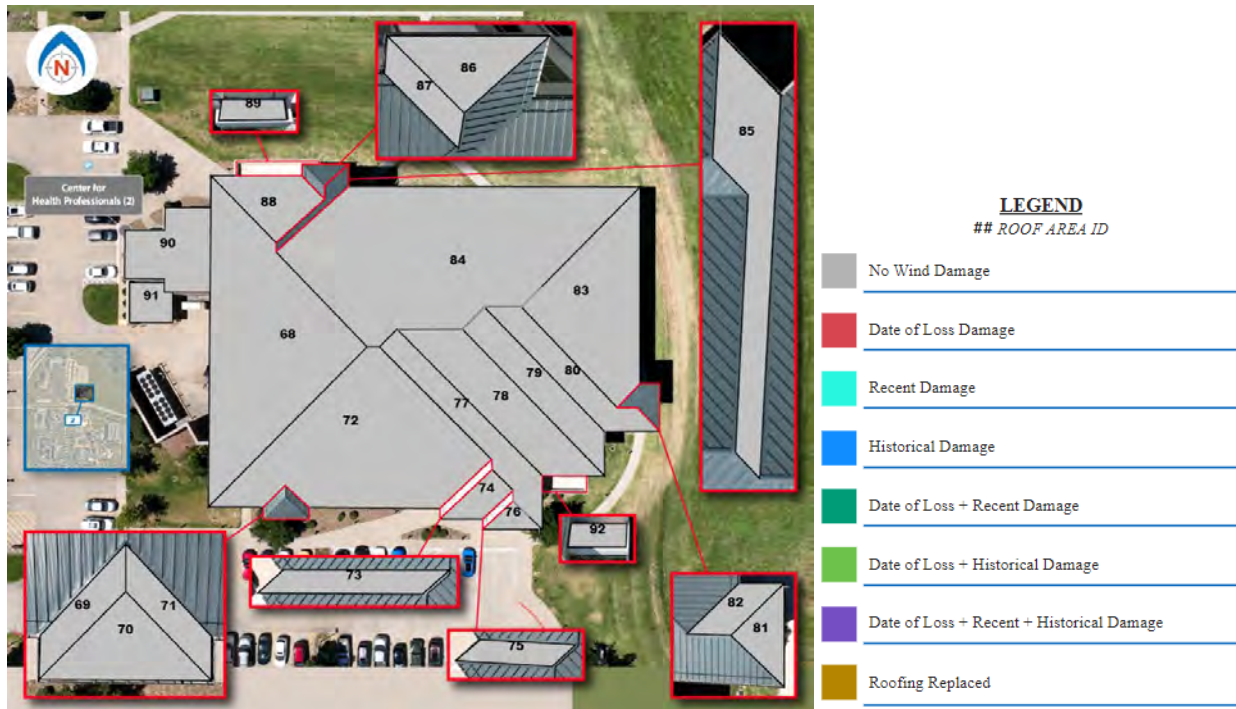
Figure 58. Excerpt of SAM Q-PDF<sup>®</sup> that depicts the locations and relative date(s) of occurrence of wind-related conditions to the roofing, by color.

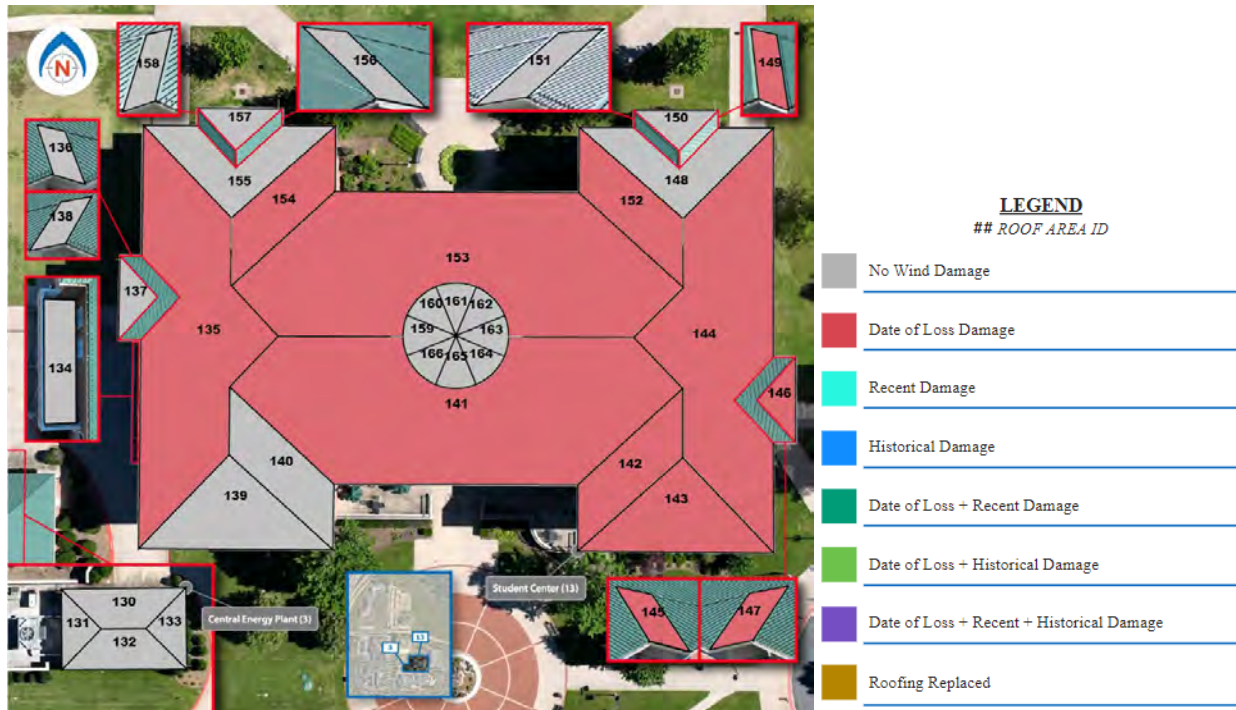
Figure 59. Excerpt of SAM Q-PDF<sup>®</sup> that depicts the locations and relative date(s) of occurrence of wind-related conditions to the roofing, by color.

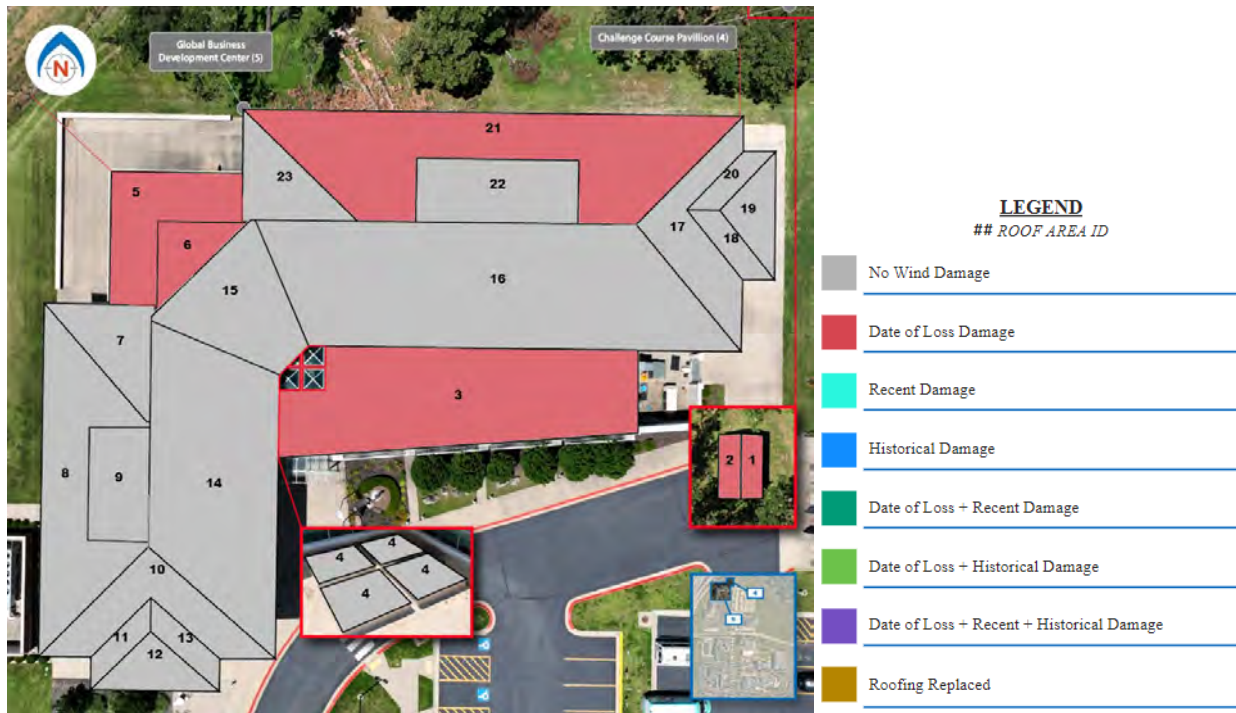
Figure 60. Excerpt of SAM Q-PDF® that depicts the locations and relative date(s) of occurrence of wind-related conditions to the roofing, by color.

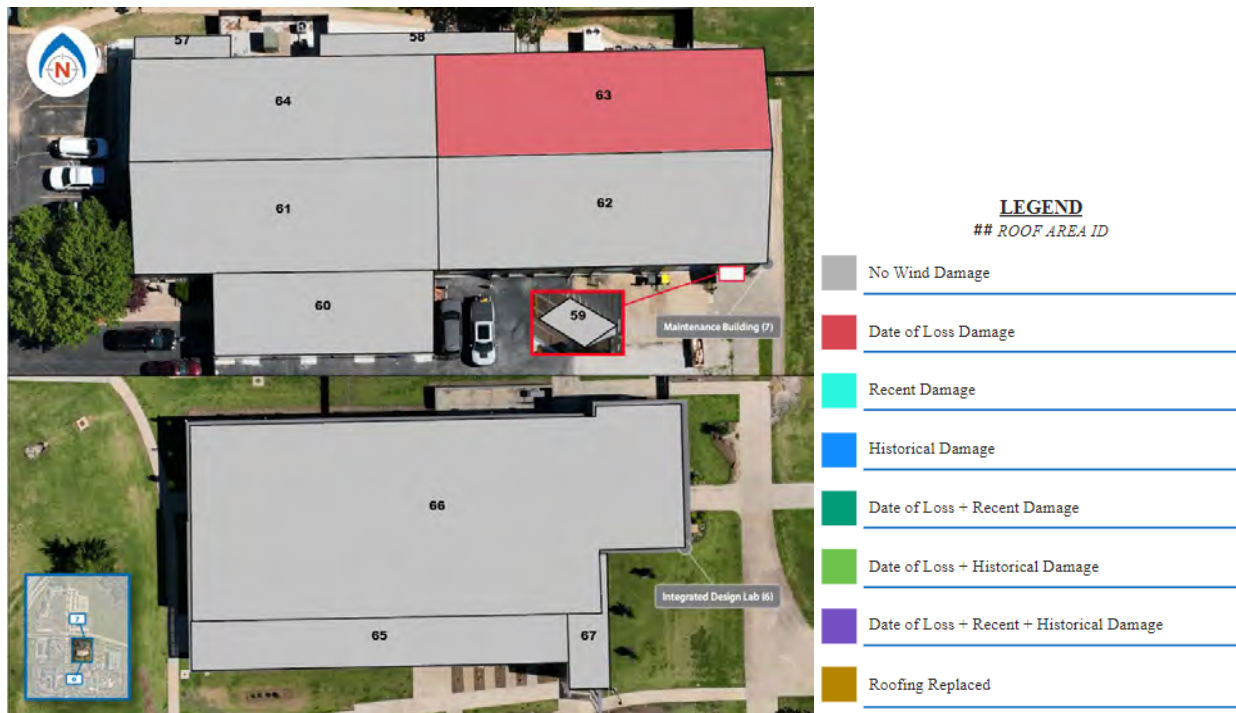
Figure 61. Excerpt of SAM Q-PDF® that depicts the locations and relative date(s) of occurrence of wind-related conditions to the roofing, by color.

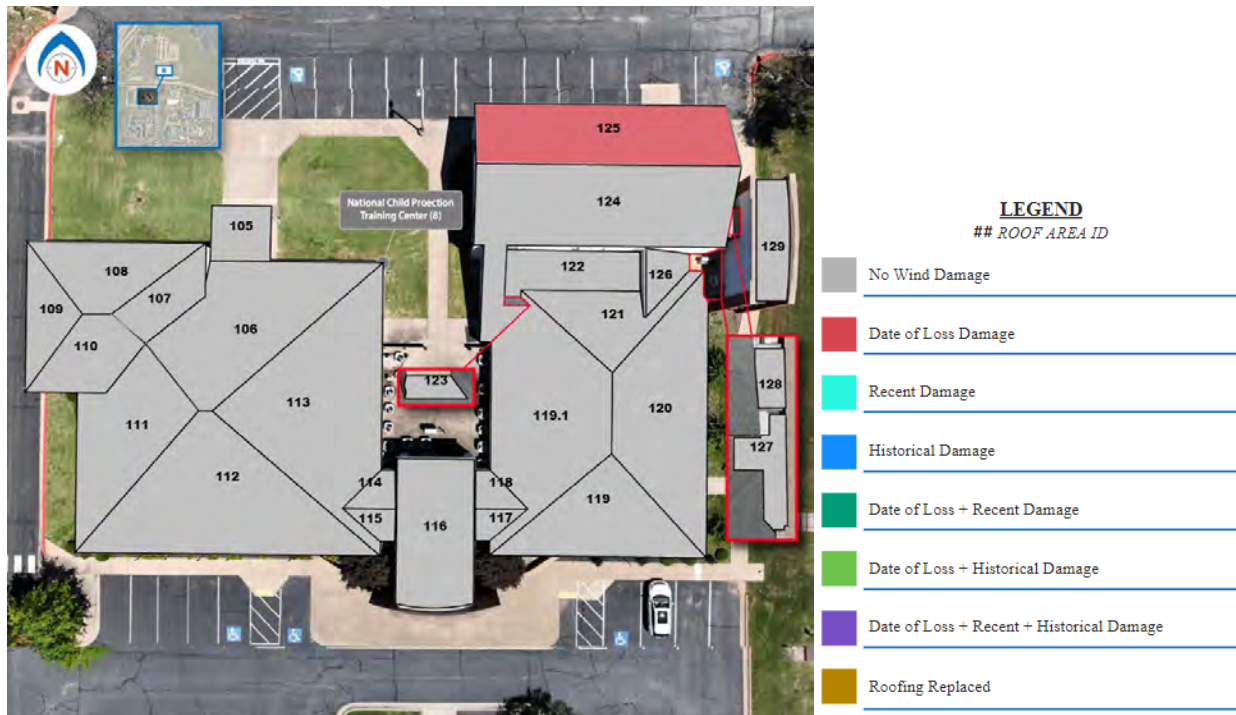
Figure 62. Excerpt of SAM Q-PDF<sup>®</sup> that depicts the locations and relative date(s) of occurrence of wind-related conditions to the roofing, by color.

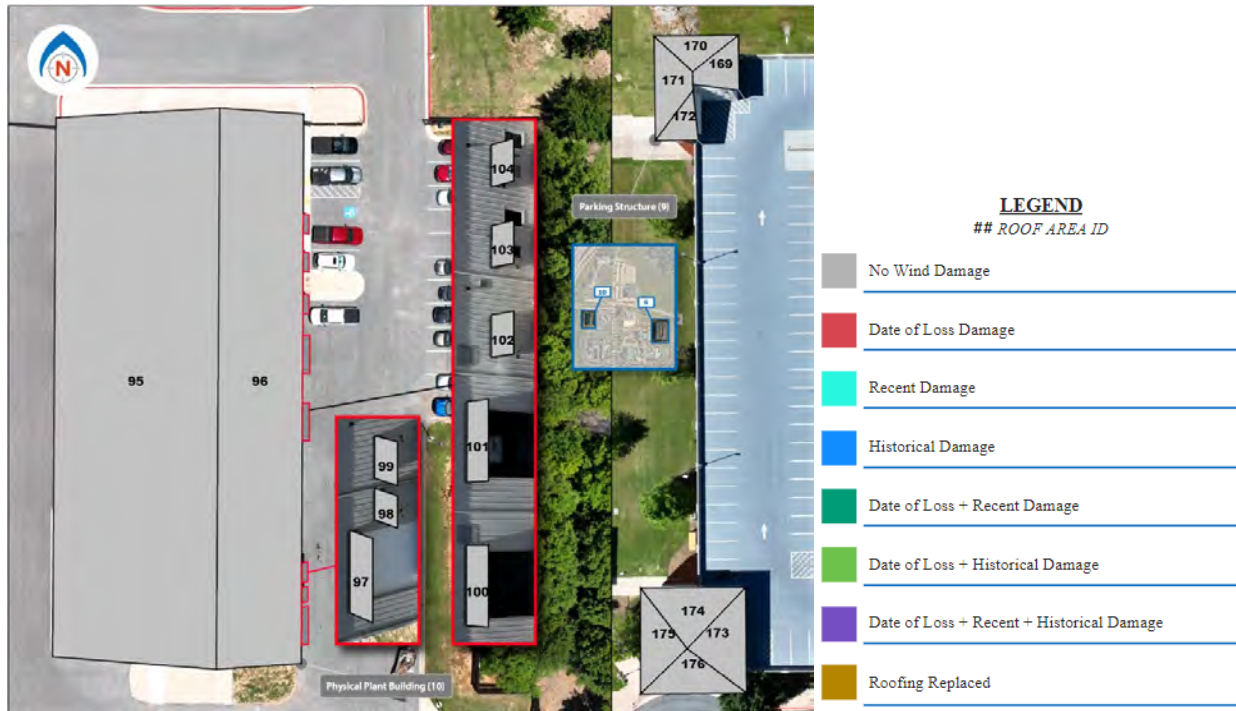
Figure 63. Excerpt of SAM Q-PDF<sup>®</sup> that depicts the locations and relative date(s) of occurrence of wind-related conditions to the roofing, by color.

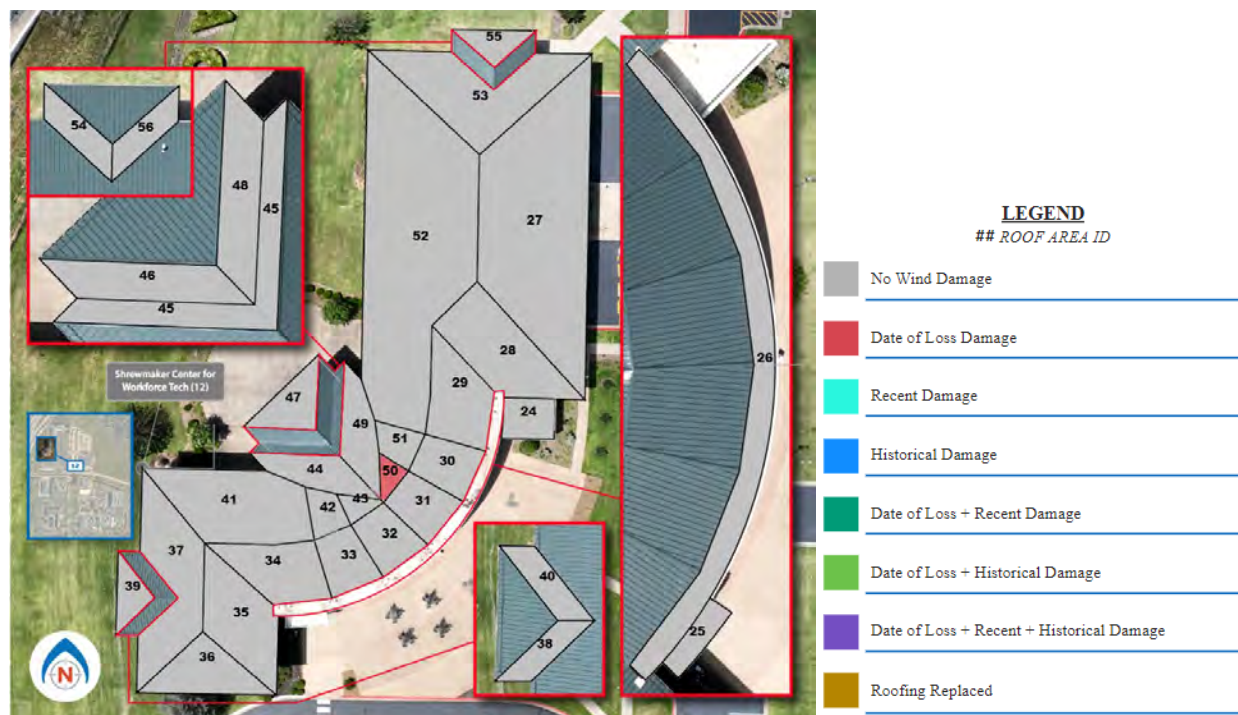
Figure 64. Excerpt of SAM Q-PDF<sup>®</sup> that depicts the locations and relative date(s) of occurrence of wind-related conditions to the roofing, by color.
