Prepared for Northwest Arkansas Community College Foundation

# NWACC Parking Garage Condition Assessment

July 26, 2027

Re: *Report for Condition Assessment - 2026*  
*Northwest Arkansas Community College Parking Garage*  
*1202 Water Tower Road*  
*Bentonville, AR 72712*  
*Walker Consultants Project #25-003478.00*

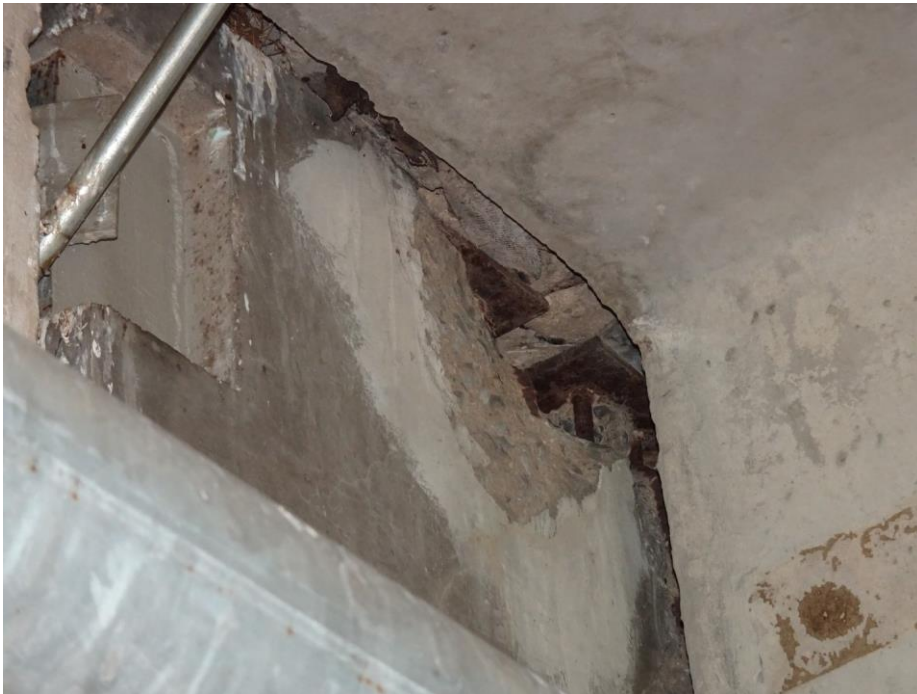
1. Spalls and delaminations were observed at isolated L-beams at Level 1. (Photos 1 and 2)
2. Spalls and delaminations were observed at isolated locations at the double-tee stems at isolated locations throughout the garage. (Photos 3 and 4)

Photo 1. Concrete L-beam spalling with exposed corroded reinforcement/embeds.

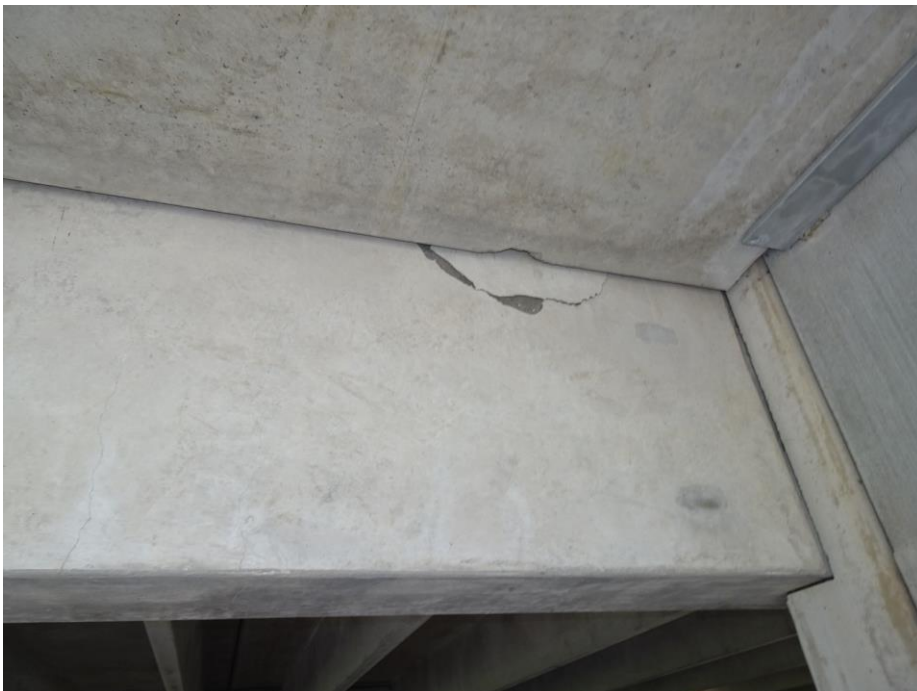
Photo 2. Typical concrete beam spalling.

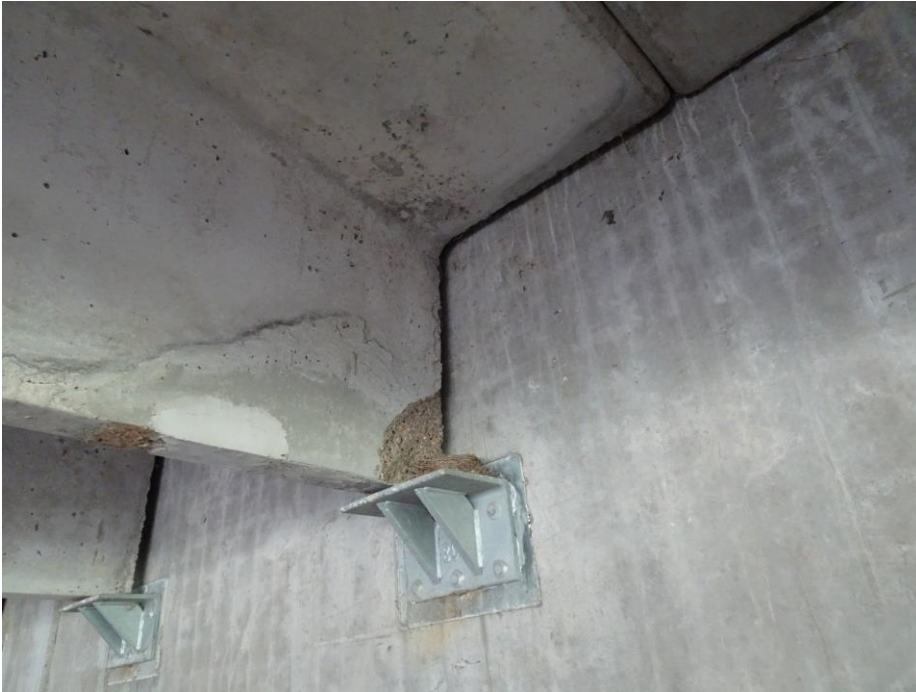
Photo 3. Spalled concrete double-tee stem.

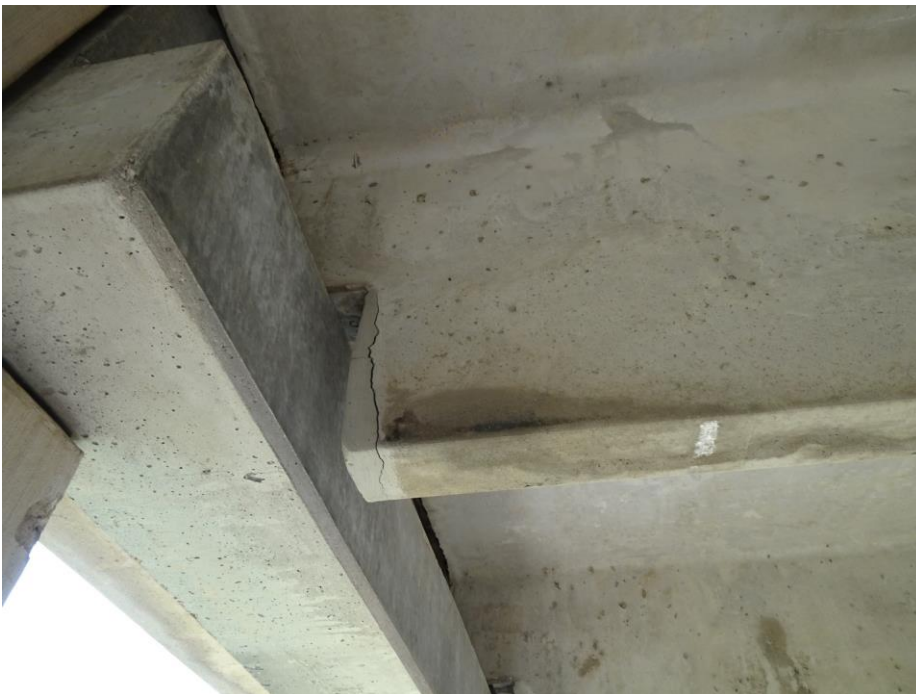
Photo 4. Concrete double-tee stem spalling.

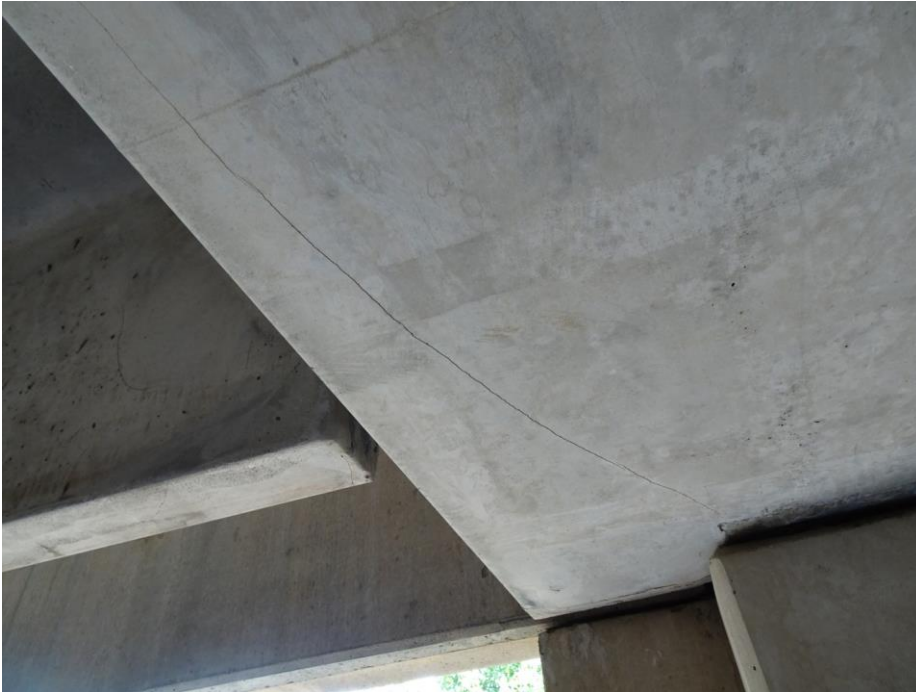
Numerous inverted-T beams at north and south ends of the garage along exhibited longitudinal cracks along their soffit. Vertical faulting of less than 1/32-inch was also observed across some of these cracks. An evaluation of the inverted-T beams is recommended to understand the cause of the cracking. An evaluation may include tests to determine the depth of the cracks, scanning of beams to determine the location and spacing of reinforcement steel, exploratory openings to determine the size of the reinforcement steel, material testing to determine the compressive strength of concrete, and an analysis of the beam. Appropriate repairs can be designed following completion of its assessment.

3. Horizontal cracks and vertical faulting were observed at the soffit of several inverted tee-girders located at the north and south ends of the garage. (Photo 5)

Photo 5. Close-up view of typical cracked inverted-tee girder throughout all levels.

1. Evaluate cracked IT Girders. Conduct repairs in accordance with the findings of this evaluation.
2. Removal of loose overhead concrete.
3. Repair Level 1 fire riser in the northwest stair tower.
4. Re-affix detached wheel stops that are tripping hazards.

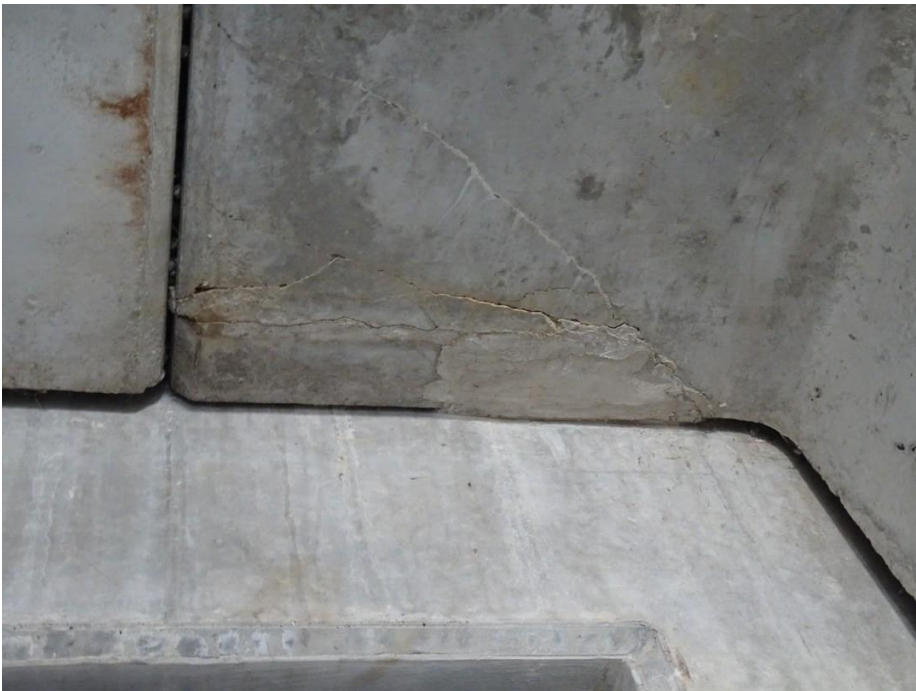
4. Spalls and delaminations were observed at isolated locations with exposed corroded reinforcement at the double-tee flanges throughout the garage. (Photos 6 and 7)

Photo 6. Typical concrete spalling at double-tee flange.

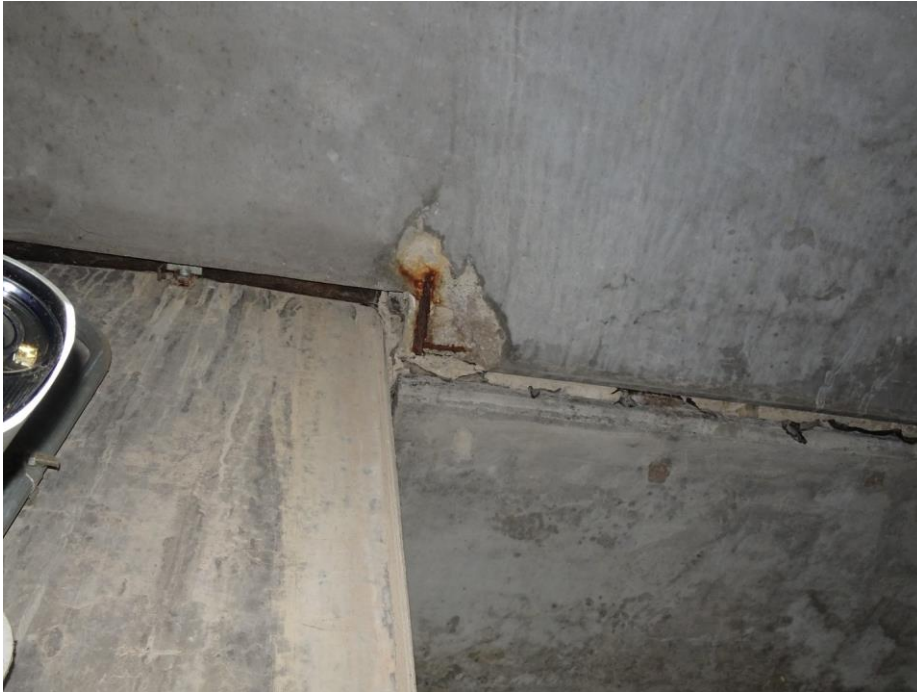
Photo 7. Spalling of double-tee flange with exposed reinforcement.

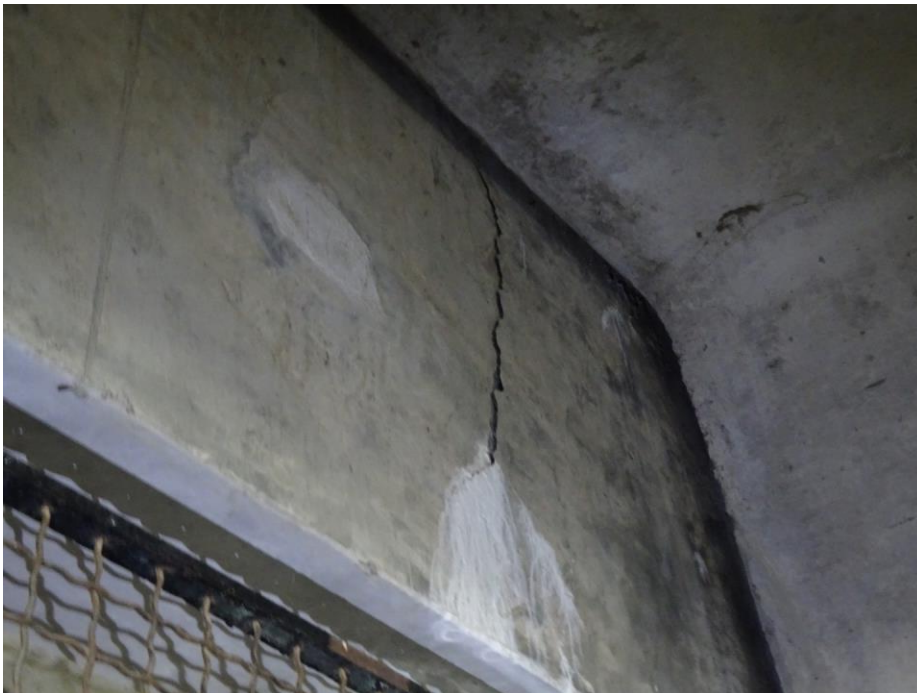
5. Spalls and delaminations were observed at isolated locations at the walls throughout the garage. (Photos 8 and 9)
6. Spalls and delaminations were observed at isolated locations on the elevated levels throughout the garage. (Photo 10)

Photo 8. Typical concrete wall spalling.

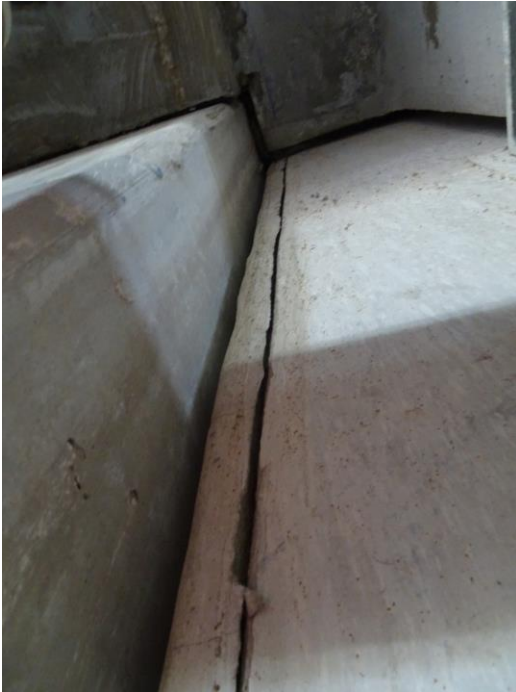
Photo 9. Concrete wall deterioration.

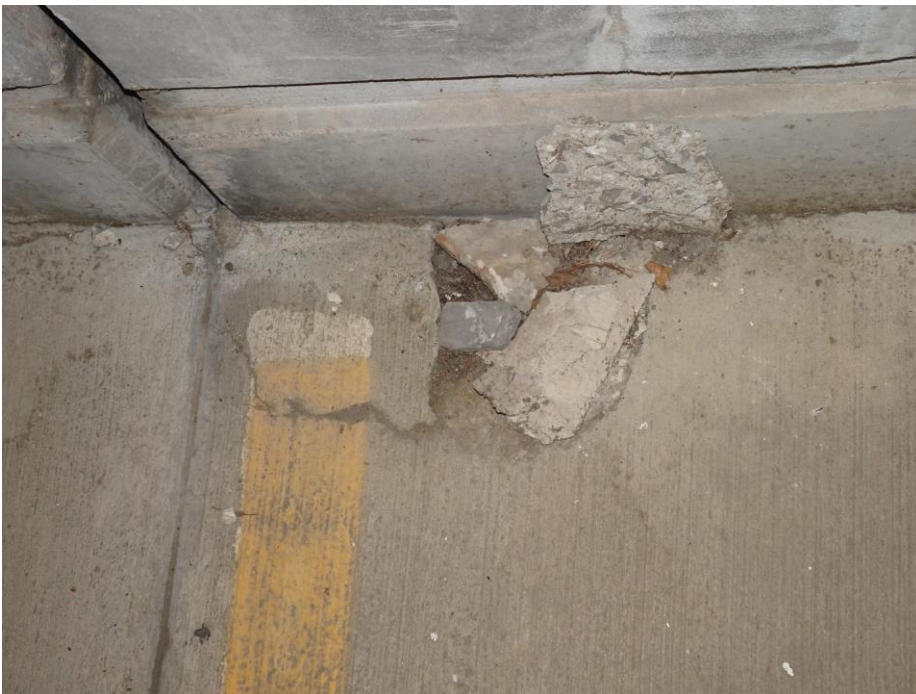
Photo 10. Close-up view of typical concrete floor spalling.

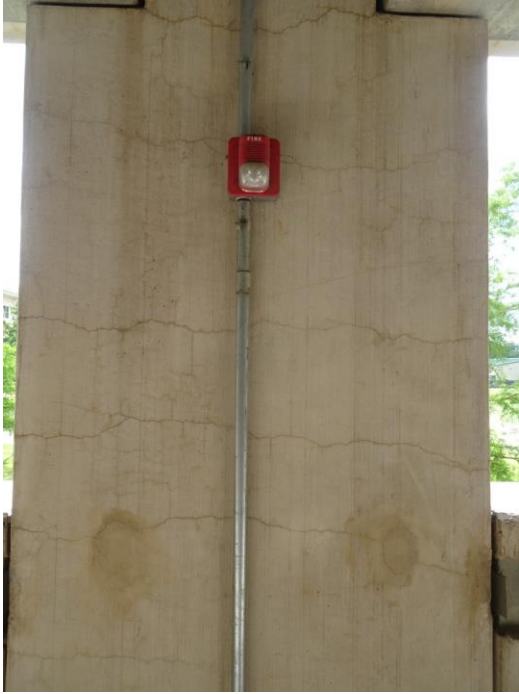
7. Cracking was observed at isolated locations on the elevated levels throughout the garage. (Photo 11)
8. Loose overhead concrete was observed at Level 1. (Photo 12)

Photo 11. Concrete with suspected material or placement issue on the Level 2. Coring & petrography would be required to confirm.

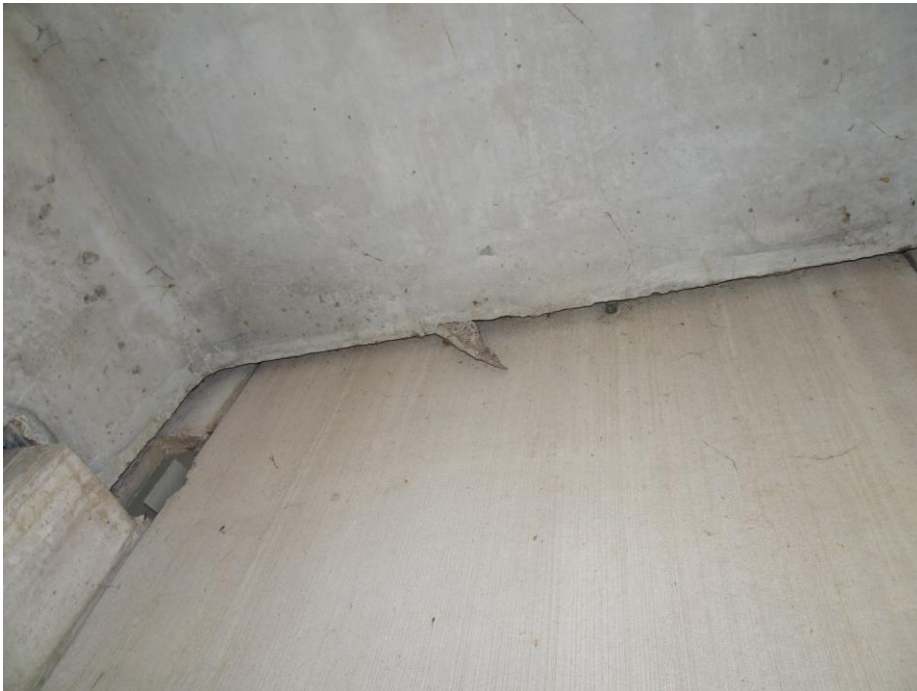
Photo 12. Loose overhead concrete indicative of a falling debris hazard at Level 1.

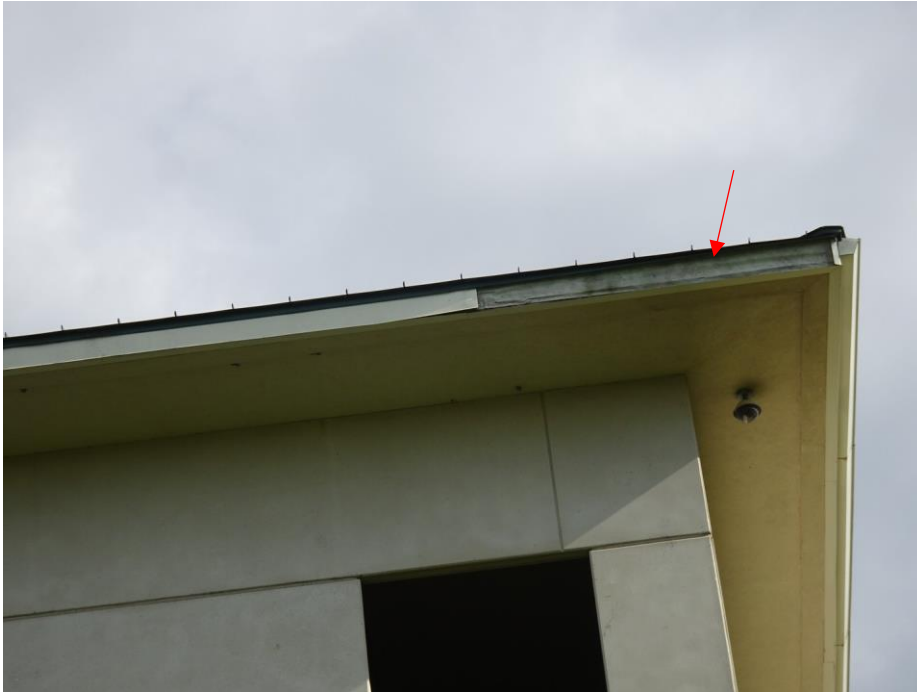
9. Missing section of roof edge metal. (Photo 13)
10. Typical spall observed at the hoist points on the wall panels. (Photos 14)
11. Deteriorated wall grout pocket. (Photo 15)

Photo 13. Roof edge metal replacement needed.

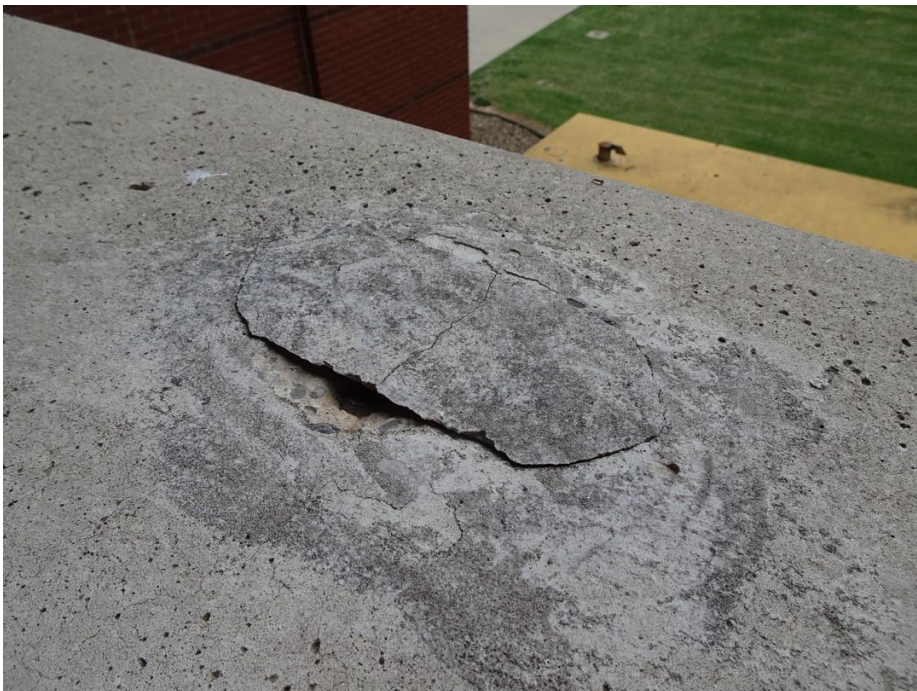
Photo 14. Close-up view of deteriorated grout pocket located on Level 2.

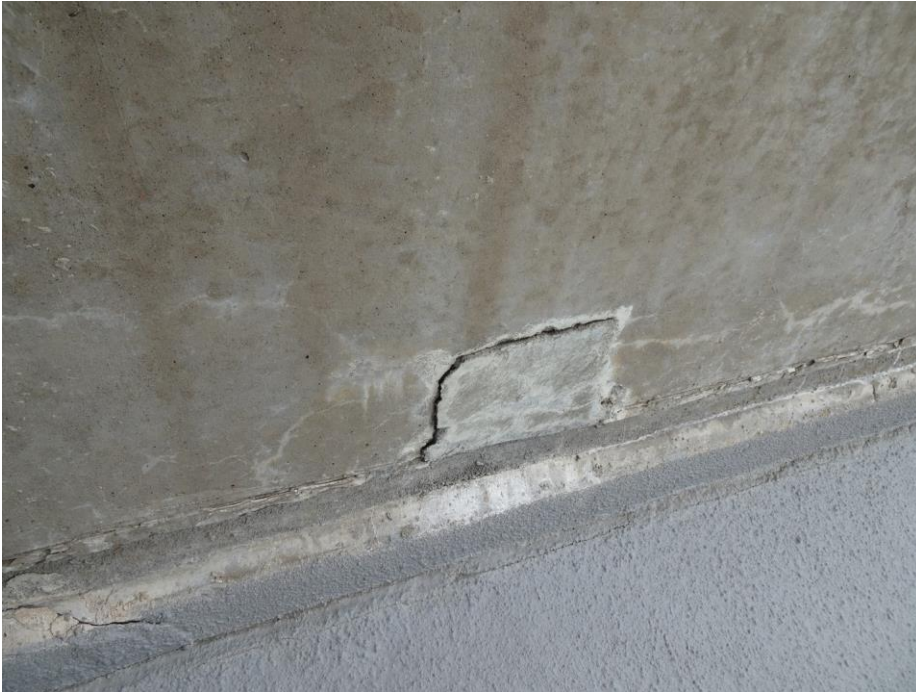
Photo 15. Typical concrete damage in need of grout pocket replacement.

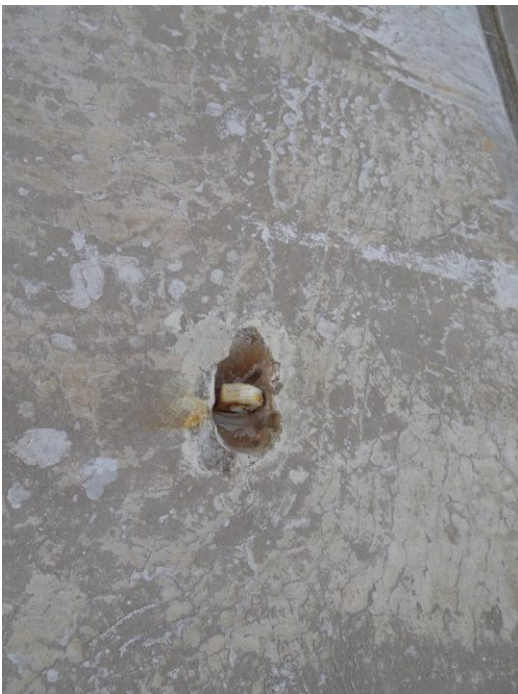
12. Ungrouted anchor point. (Photo 16)
13. Vertical joint sealants were observed to be failed or at the end of their useful service life throughout the garage. (Photo 17)

Photo 16. Close-up view of typical ungrouted anchors.

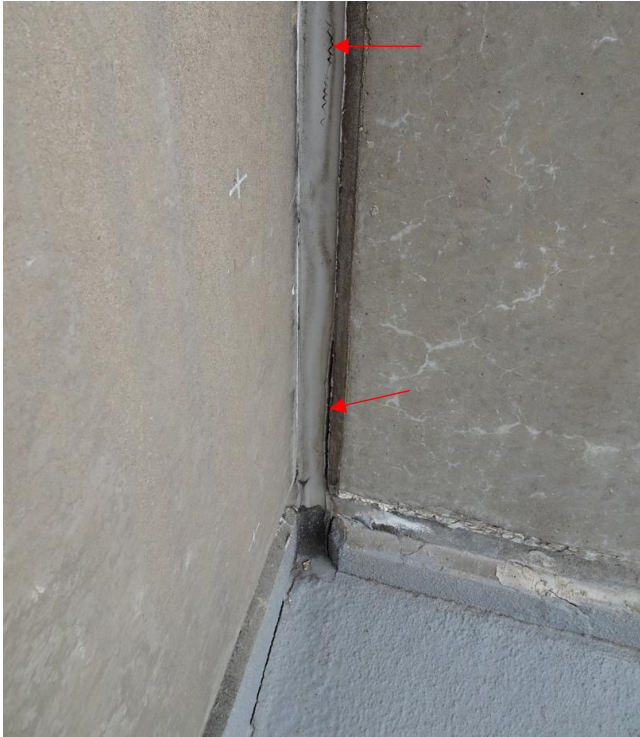
Photo 17. Typical deteriorated vertical joint sealant.

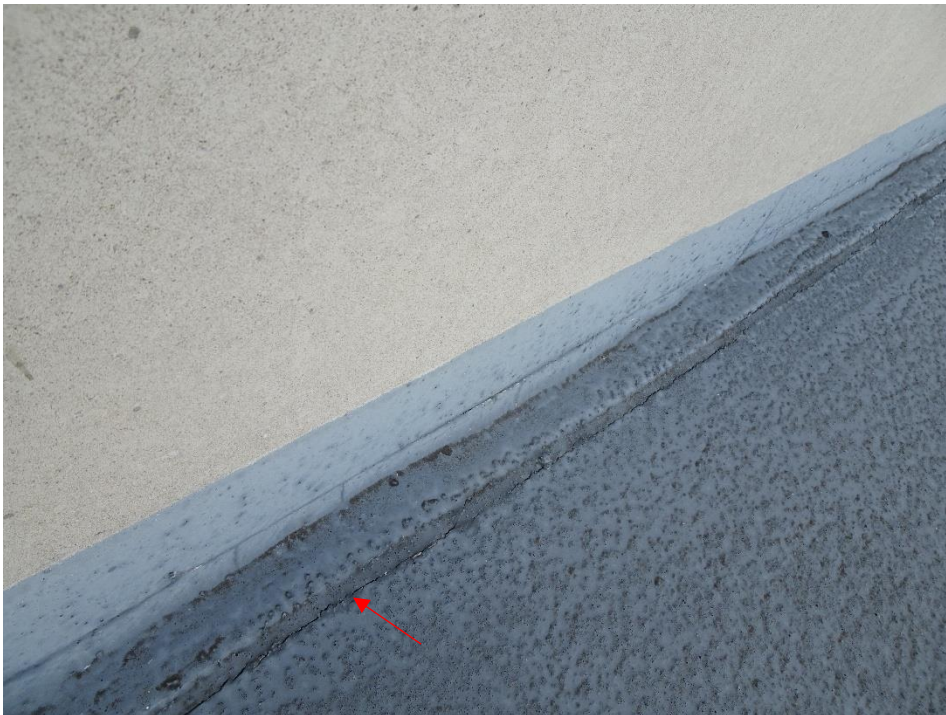
14. Failed cove sealant was observed at isolated locations. (Photo 18)
15. Traffic coating in need of repair was noted at Level 5. (Photo 19)
16. Traffic marking were observed to be faded at isolated locations. (Photo 20)

Photo 18. Typical deteriorated cove sealant.

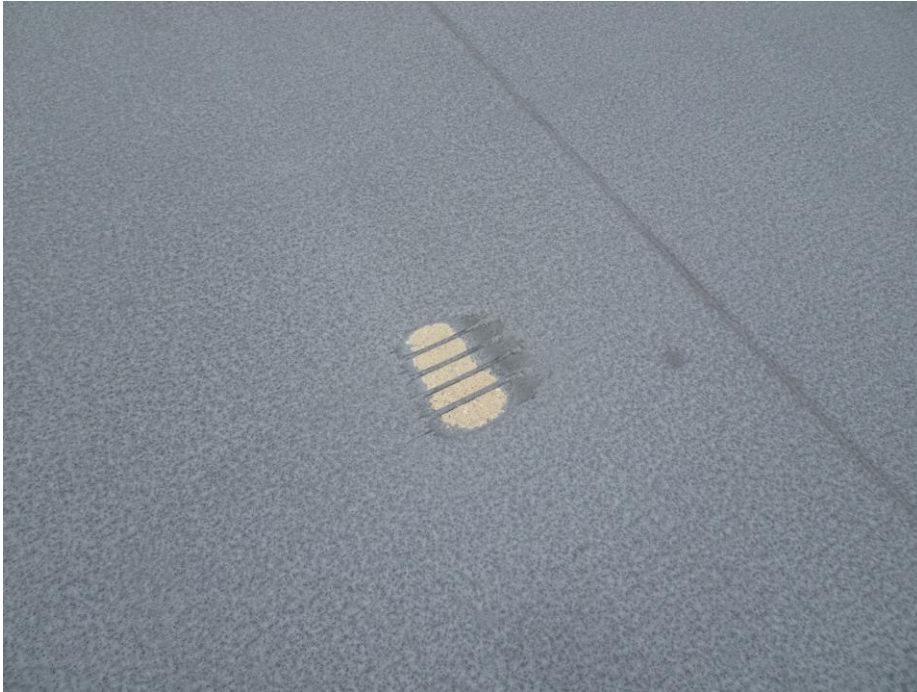
Photo 19. Traffic coating repair needed on the fifth level.

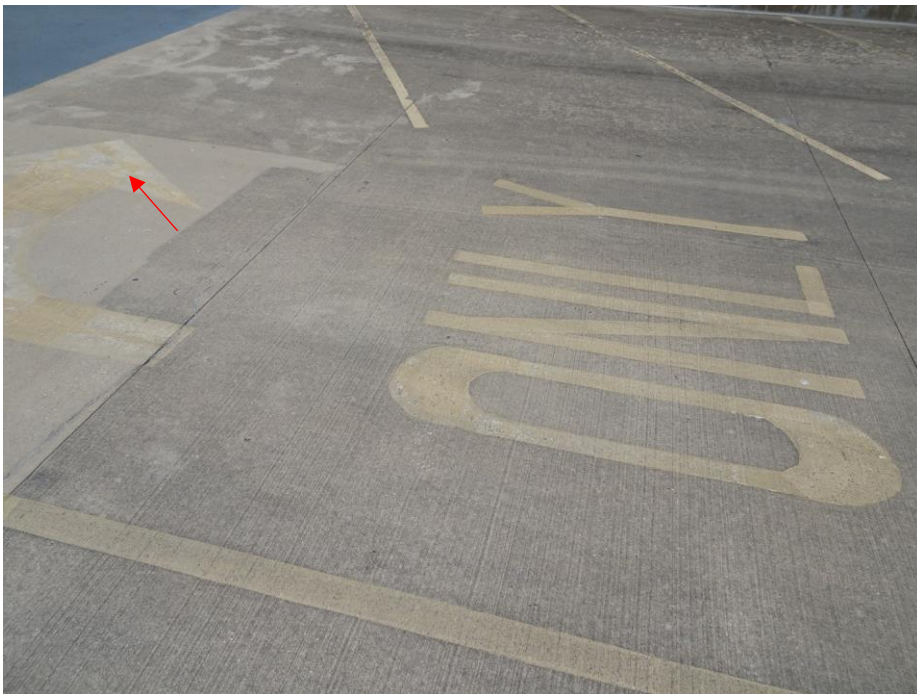
Photo 20. Faded traffic markings on the fifth level.

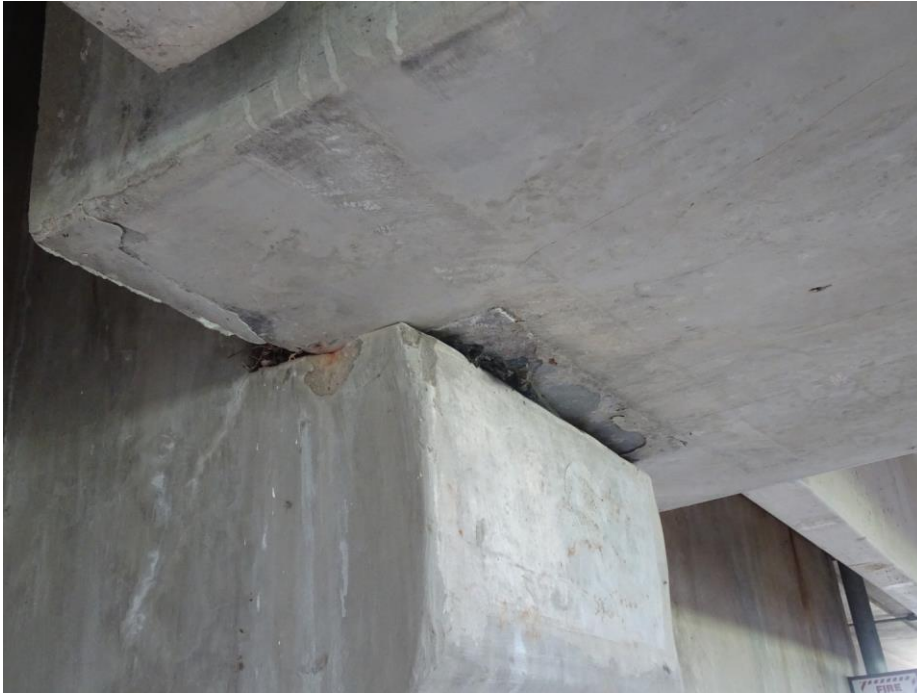
Mislocated double-tee bearing pads are typically due to inadequate placement during erection, aggressive span-to-depth ratios, or movement of the double-tees due to temperature differential and loading. A term typically used in the industry for this phenomenon is "walking bearing pads". The bearing pads are intended to provide a flat surface for the double-tee stem soffit to bear evenly on the support elements (concrete haunches and inverted tee beams in this case). If the contact surface between the double-tee stem soffit and the bearing pad decreases, the bearing capacity of the support condition also decreases. In other words, walking bearing pads could compromise the bearing support capacity of double-tee stems. While Walker observed evidence of some distress of the double-tees related to mislocated bearing pads, the extent of the stress was limited and the bearing support appeared to be adequate at the time of evaluation. However, we recommend the walking bearing pads be replaced and double-tee stems repaired. Further, the walking bearing pads in rest of the garage should also be replaced to reduce the possibility of future double-tee stem bearing support distress.

17. Walking bearing pads observed at isolated locations. (Photo 21)
18. Door frames were observed to be corroded at throughout. (Photo 22)
19. Wheel stops were observed to be displaced (tripping hazard). (Photo 23)

Photo 21. Walking bearing pad between corbel and inverted-tee girder at Level 4.

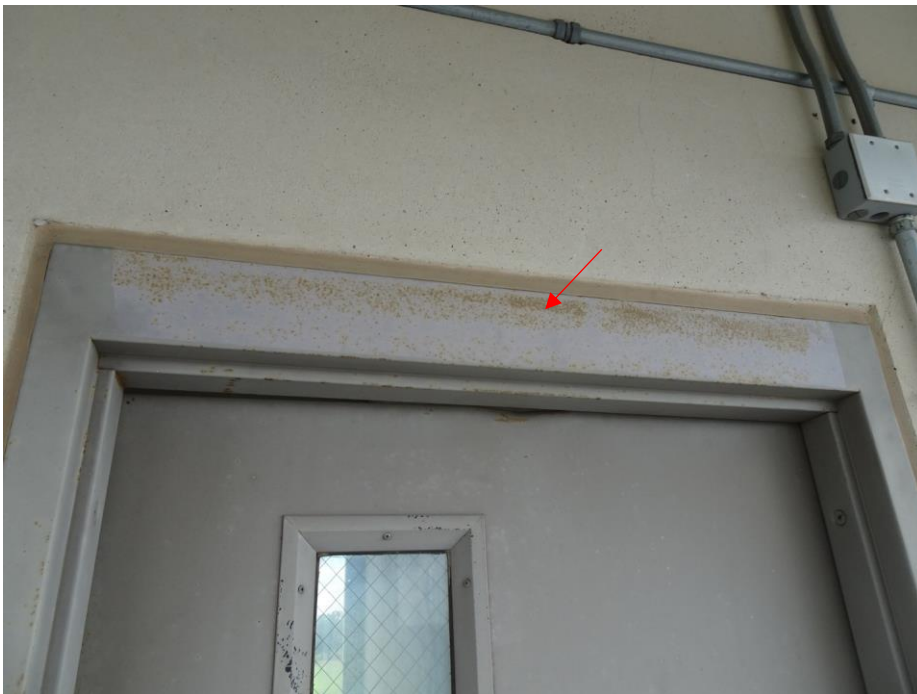
Photo 22. Corroded door frame on Level 5.

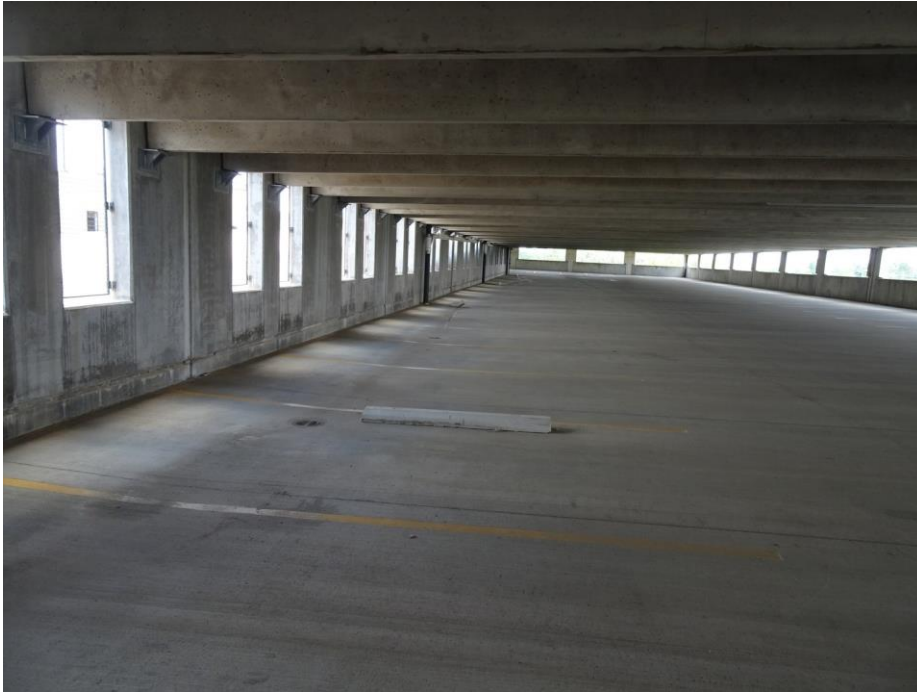
Photo 23. Dislocated Wheel Stop on the Fourth Level.

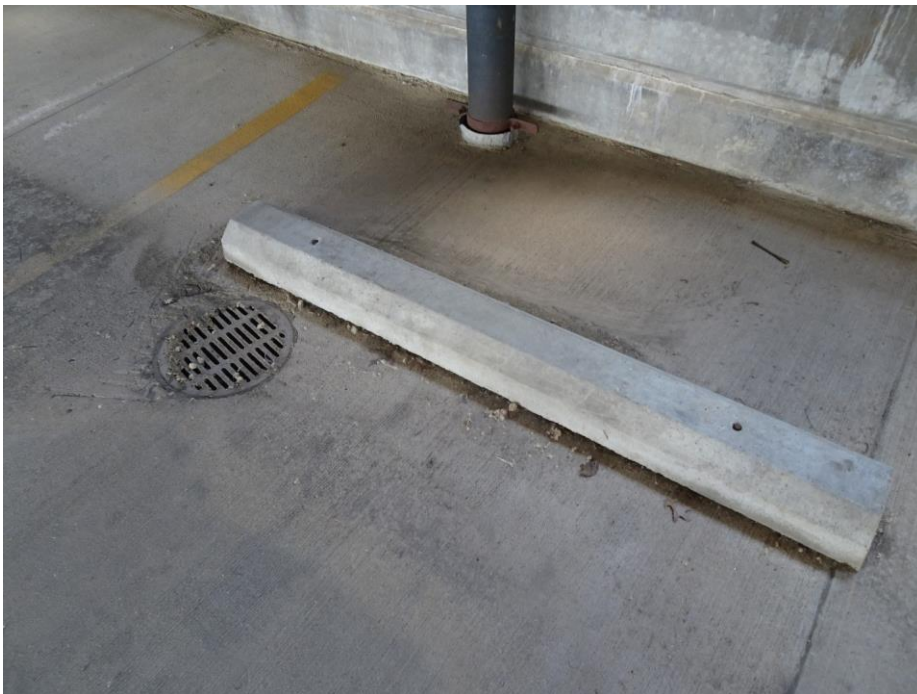
20. Wheel stops were observed to be bare concrete. (Photo 24)
21. Curb was observed to have sections of bare concrete. (Photo 25)
22. Drainpipe insulation was observed to be damaged at Level 1. (Photo 26)

Photo 24. Typical wheel stops not painted yellow.

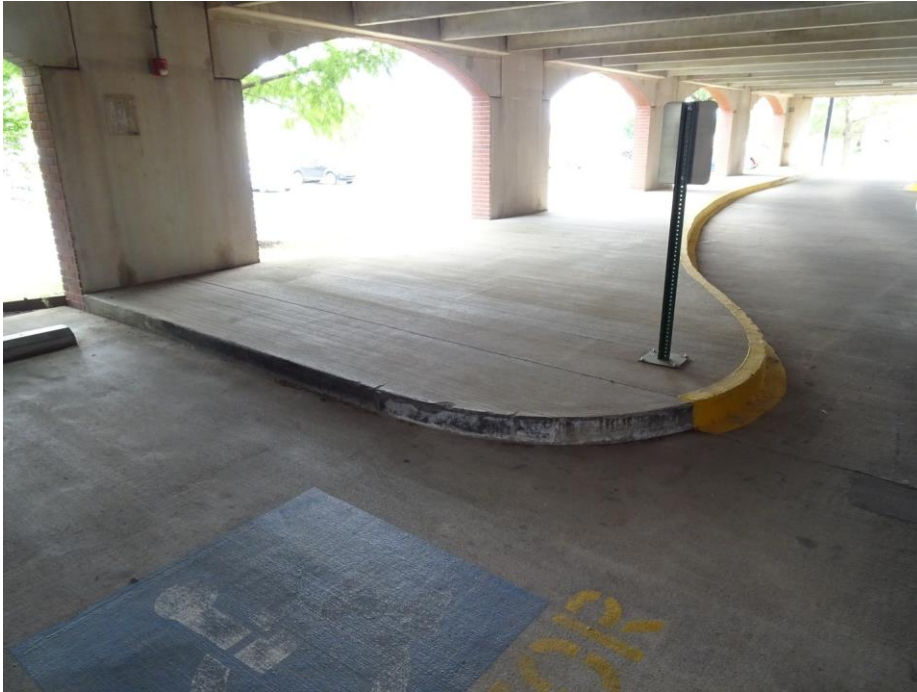
Photo 25. Incomplete curb painting on Level 1.

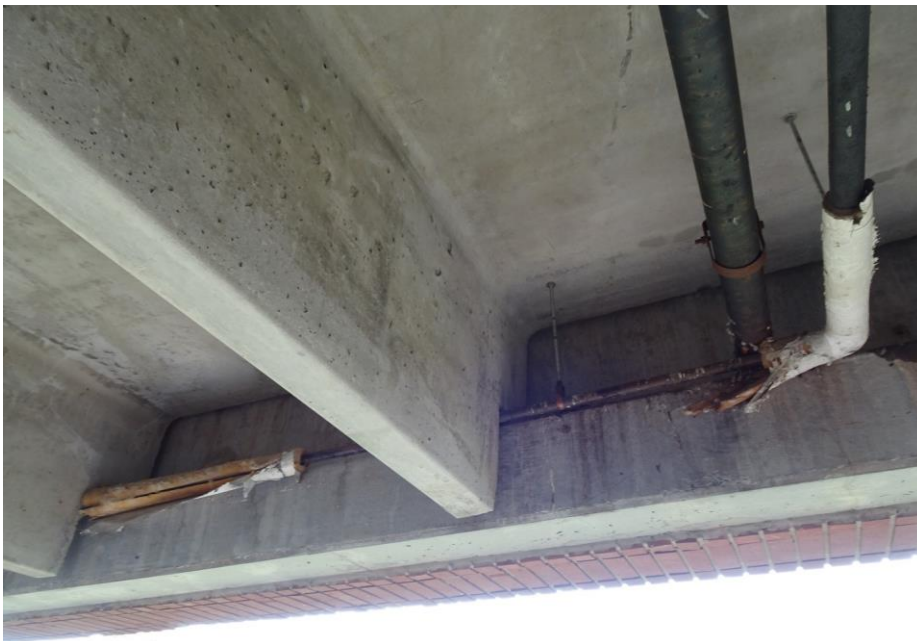
Photo 26. Damaged piping at Level 1.

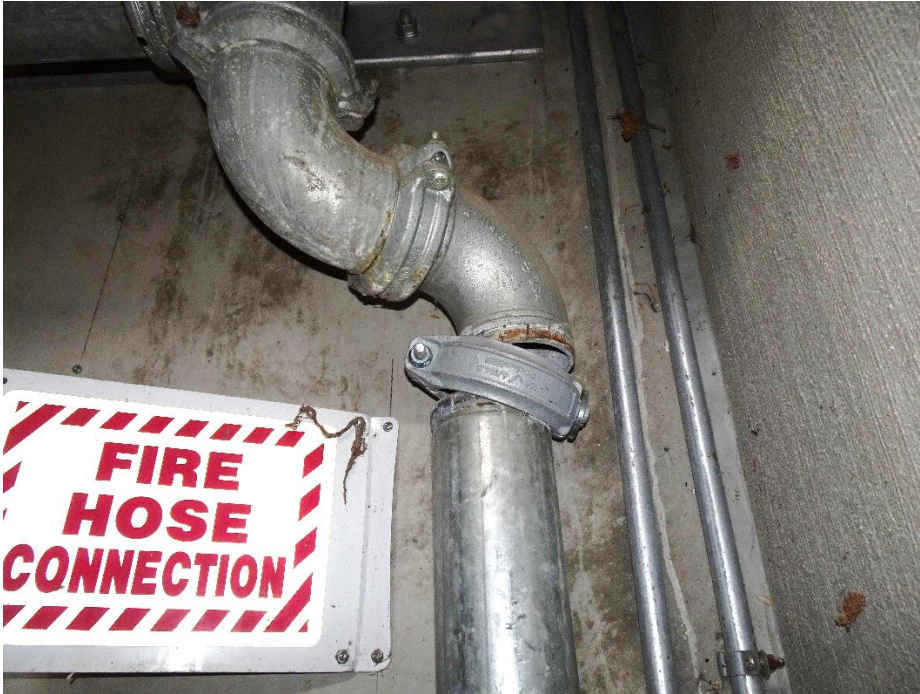
A detailed assessment of the plumbing system was not performed; however, drainpipes were observed to be damaged at isolated locations on Level 1. The cast iron drains should be cleaned off dirt and debris as they were observed to be clogged at isolated locations. Further, a fire riser in the northwest stair tower was observed to not be connected.

23. Fire riser was observed to be damaged at Level 1. (Photo 27)
24. 'Level 5' sign was observed to be missing at the southwest stairwell. (Photo 28)

Photo 27. Damaged fire riser on Level 1.

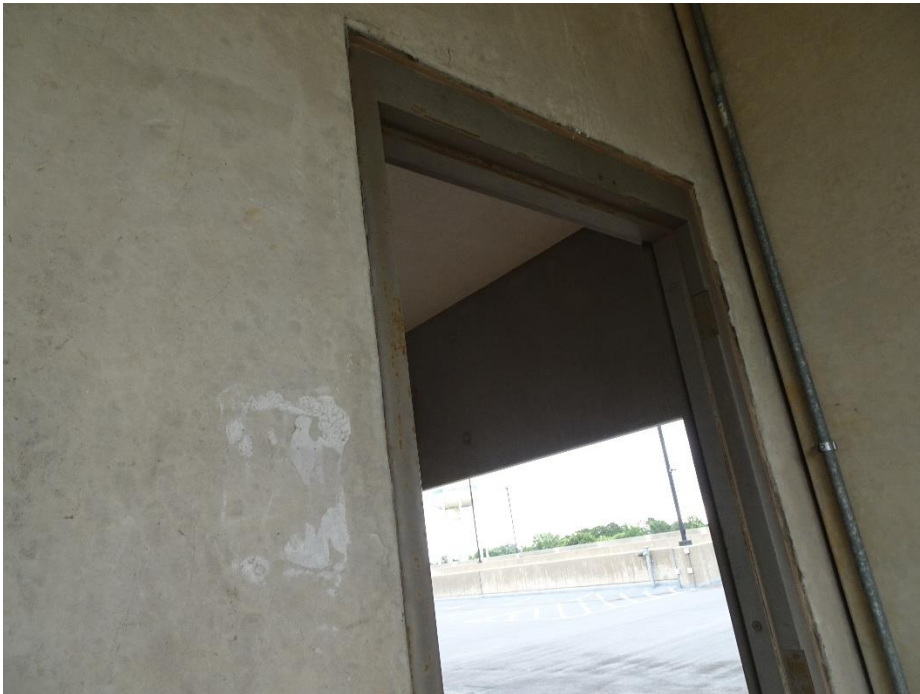
Photo 28. Missing level sign on level 5.
