August 28, 2024

C.C. (Chris) Andersen  
**Central Adjustment Company, Inc.**  
Post Office Box 25068  
Little Rock, Arkansas 72221

RE: File No: **173616**  
Insured: 198 Northwest Arkansas Community College  
Address: One College Drive  
Bentonville, Arkansas 72712  
Date of Loss: May 26, 2024  
BSC File No: 240353.S-01-1

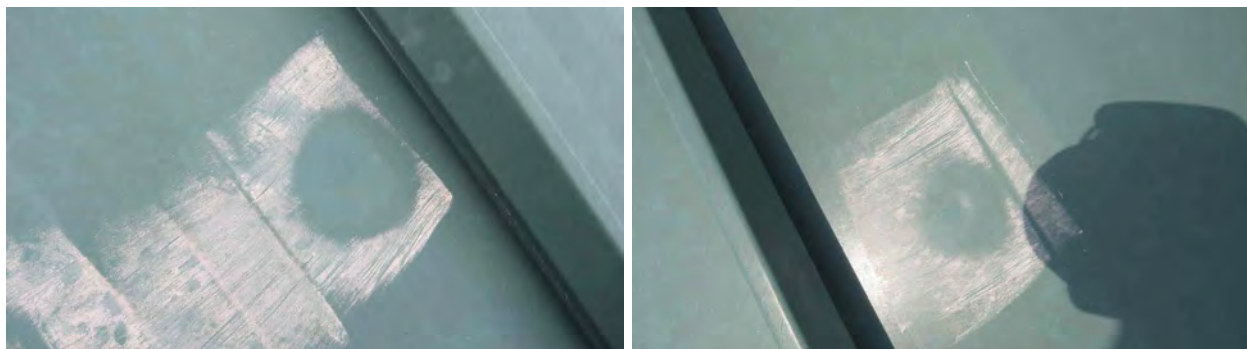
**Metal Panels (Various Roof Areas):** BSC's inspection revealed relatively widespread patterned indentations with no perforations, tears, or disengaged seams/overlaps (cosmetic) consistent with hail impacts. The size, distribution, and directional manifestation of the hail-related conditions were primarily consistent with hail impacts during the reported event; however, various roof areas detailed herein also exhibited historical hail-related cosmetic indentations. The hail impact-related conditions were consistent with the size and distribution of hail evidence documented at the subject property, associated with both the reported event and one (1) or more historical events. The extent of hail-related roofing conditions are detailed in the *SAM Q-PDF*<sup>®</sup> documents herein and within the attached Appendices. It is BSC's professional opinion that hail-related conditions consistent with both the reported event and one (1) or more historical event(s) had been documented along the various metal panel roof areas at the subject campus.

Figure 12. Roofing on the Bob Burns hall (1) with hail-related conditions.

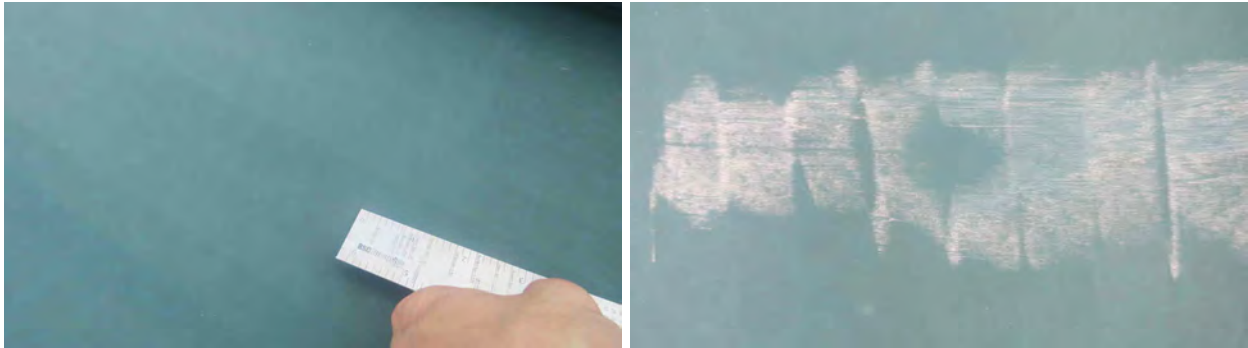
*Figure 14. Roofing on the central energy plant (3) with hail-related conditions.*

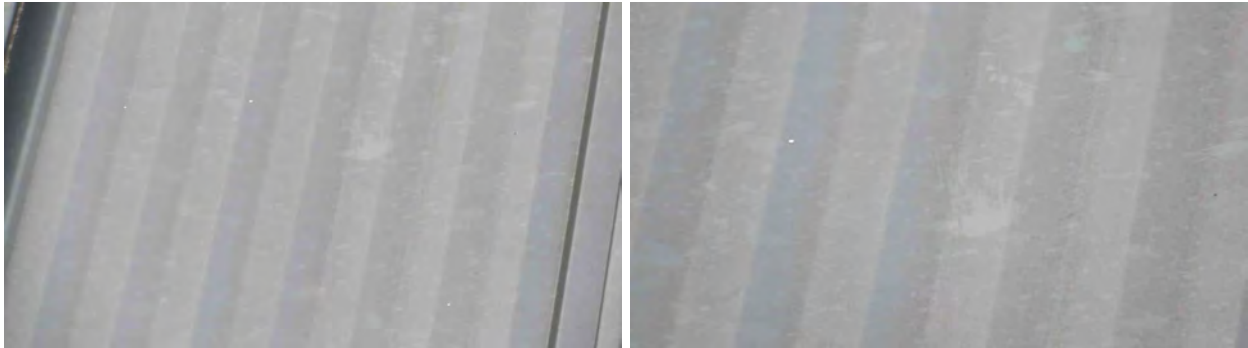
*Figure 18. Roofing on the center for health professionals (2) with no hail damage.*

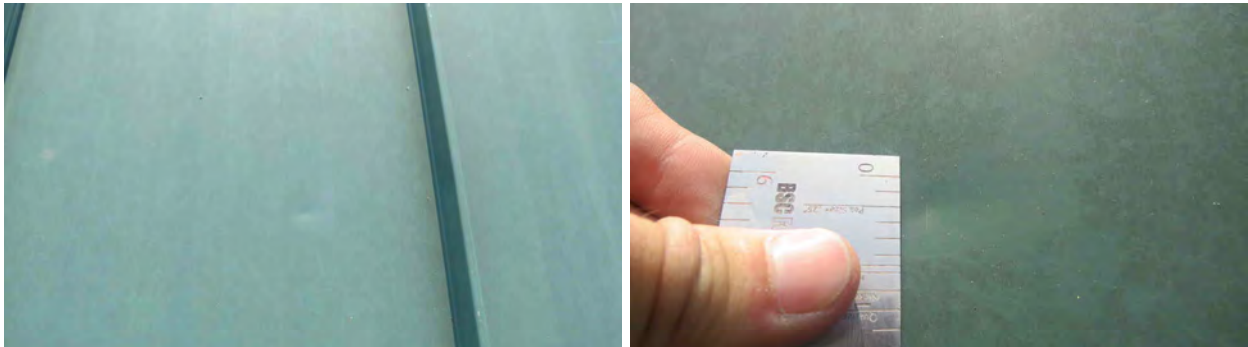
*Figure 19. Roofing on the student center (13) with hail-related conditions.*

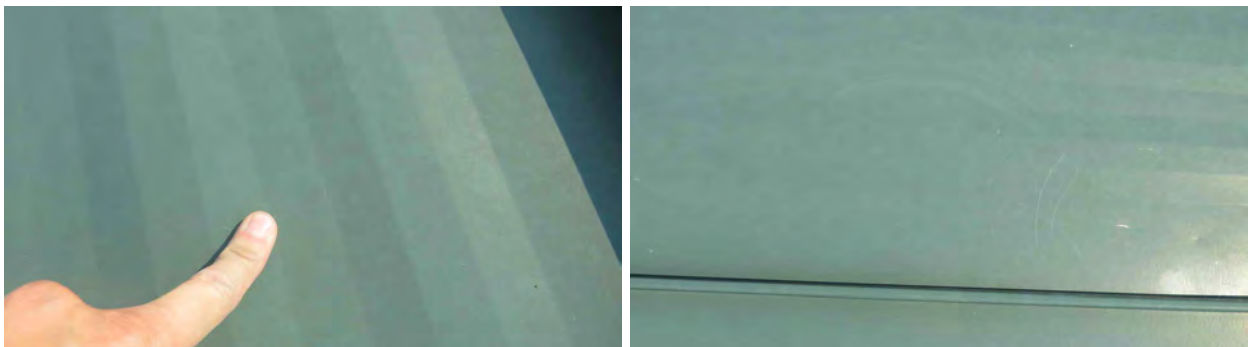
*Figure 20. Roofing on the student center (13) with no hail damage.*

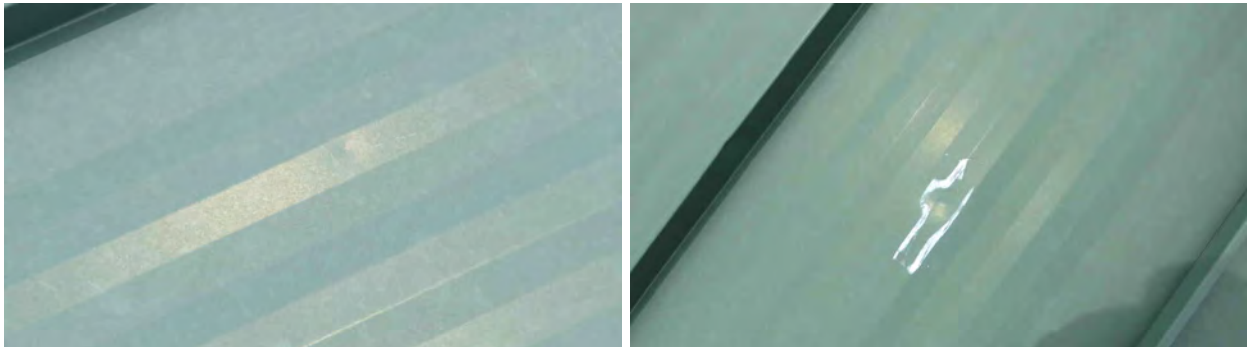
*Figure 23. Roofing on the global business development center (5) with hail-related conditions.*

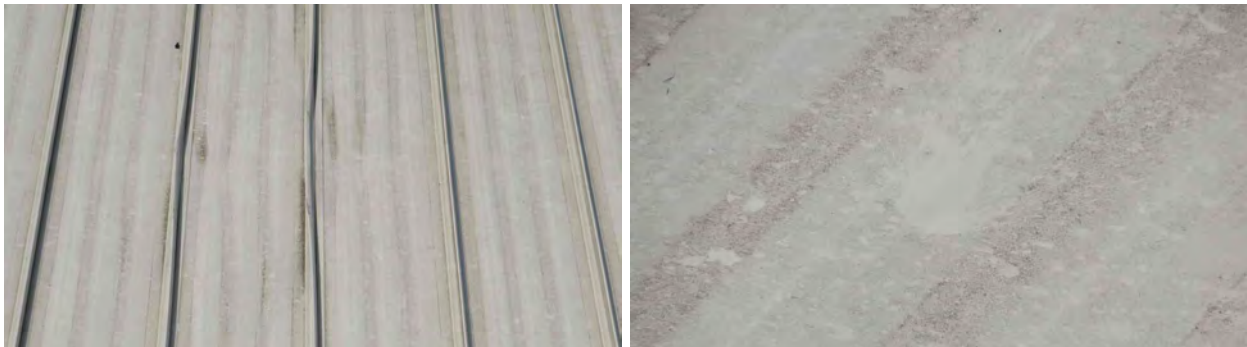
*Figure 24. Roofing on the integrated design lab (6) with hail-related conditions.*

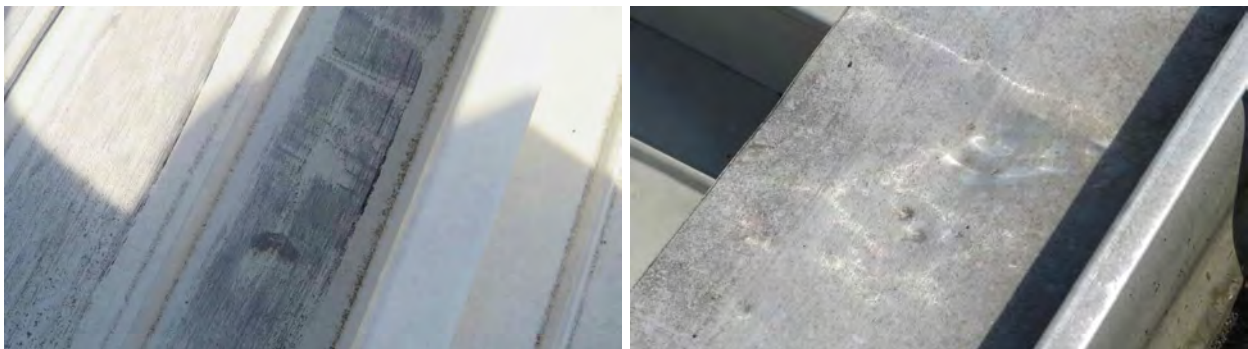
*Figure 28. Roofing on the national child protection training center (8) with hail-related conditions.*

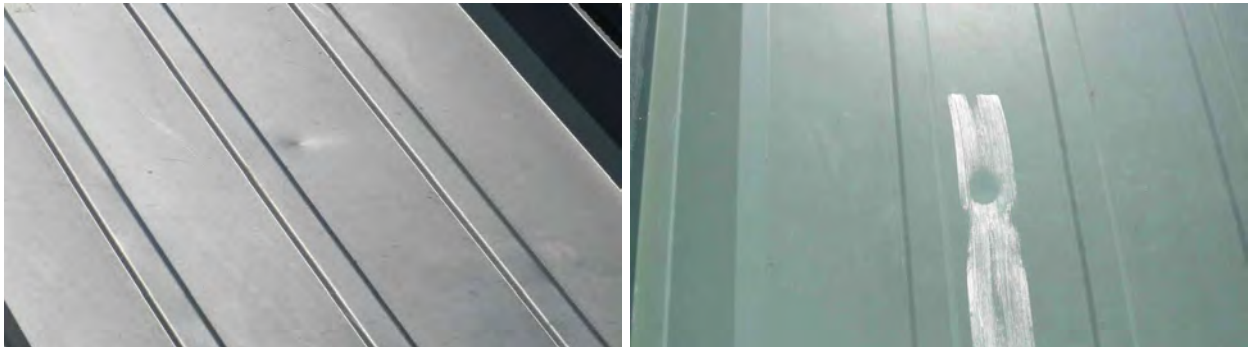
*Figure 31. Roofing on the physical plant building (10) with hail-related conditions.*

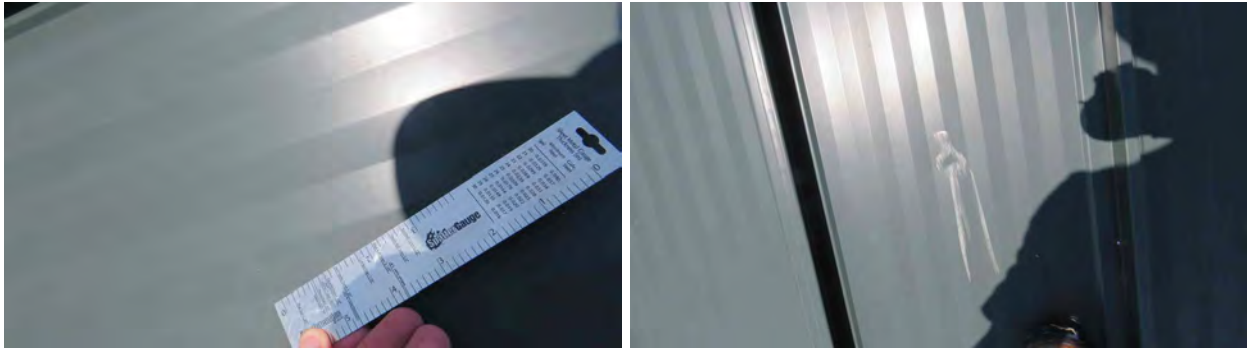
Figure 34. Roofing on the Shrewmaker center for workforce tech (12) with hail-related conditions.

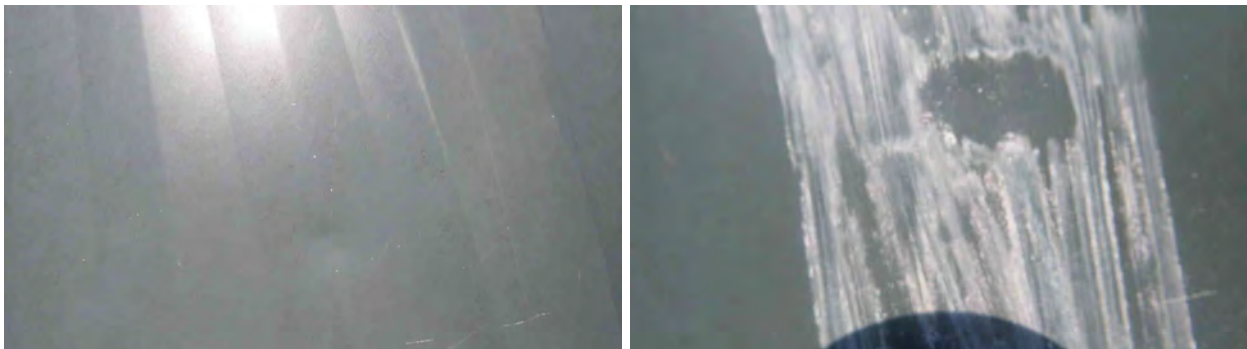
Figure 35. Roofing on the Shrewmaker center for workforce tech (12) with hail-related conditions.

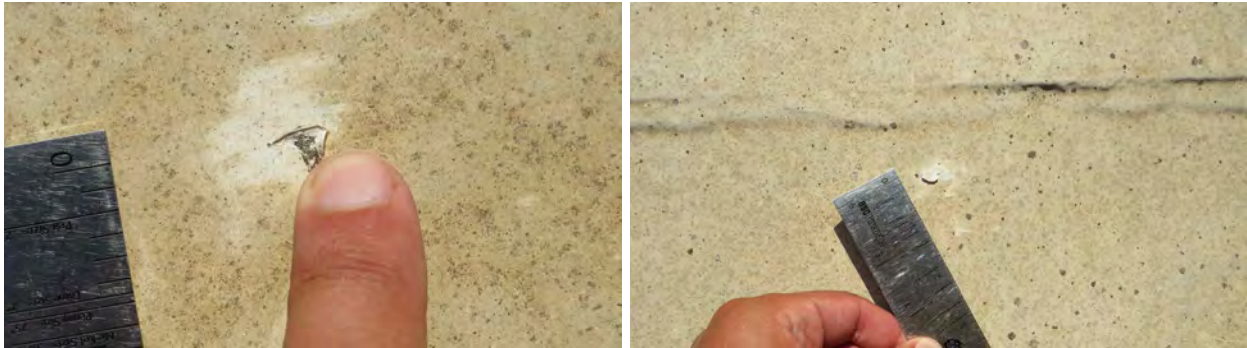
**Sealant-Coated Built-Up Roofing (Various Roof Areas):** BSC's inspection revealed patterned tears, gouges, and/or abrasions in the sealant coating on the various roof areas with corresponding spatter marks. The hail impact-related conditions were consistent with the size and distribution of hail evidence documented at the subject property, associated with the reported event. The extent of hail-related conditions is detailed in the *SAM Q-PDF*<sup>®</sup> documents herein and within the attached Appendices. It is BSC's professional opinion that hail-related conditions consistent with the reported event had been documented on the various sealant-coated built-up roofing areas.

*Figure 36. Roofing on the bob burns hall (1) with hail-related conditions.*

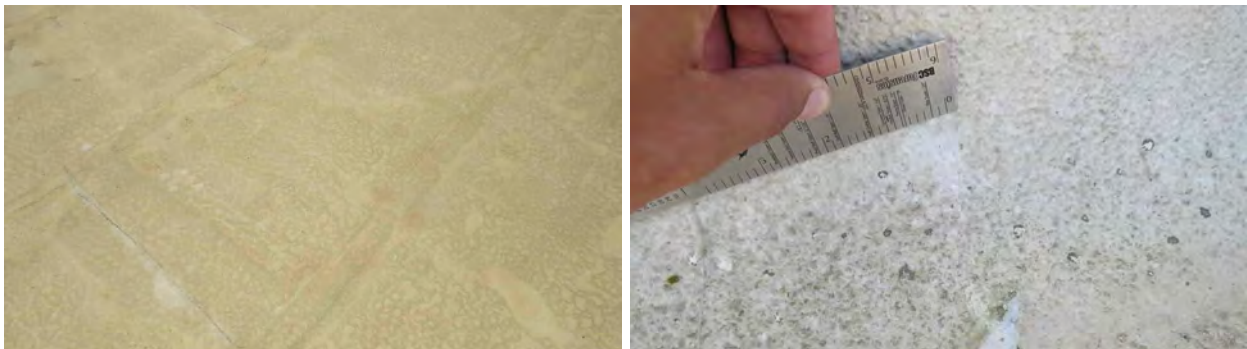
*Figure 38. Roofing on the national child protection training center (8) with no hail damage.*

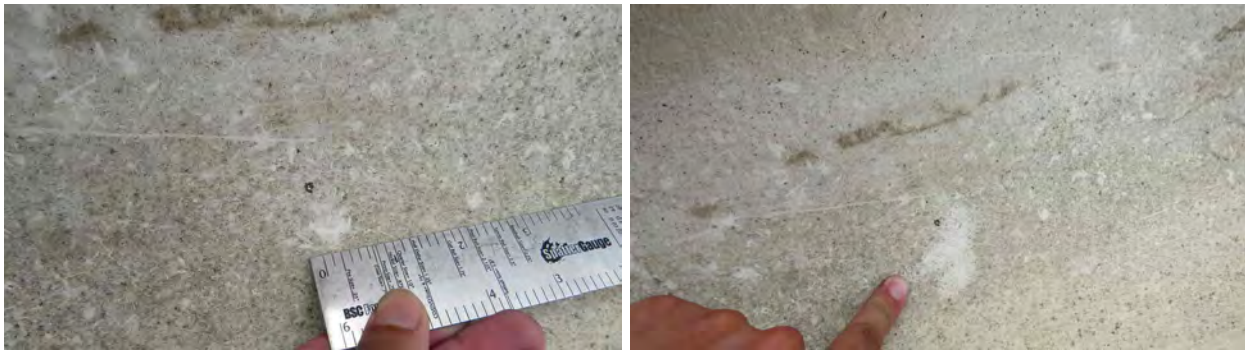
*Figure 39. Roofing on the global business development center (5) with no hail damage.*

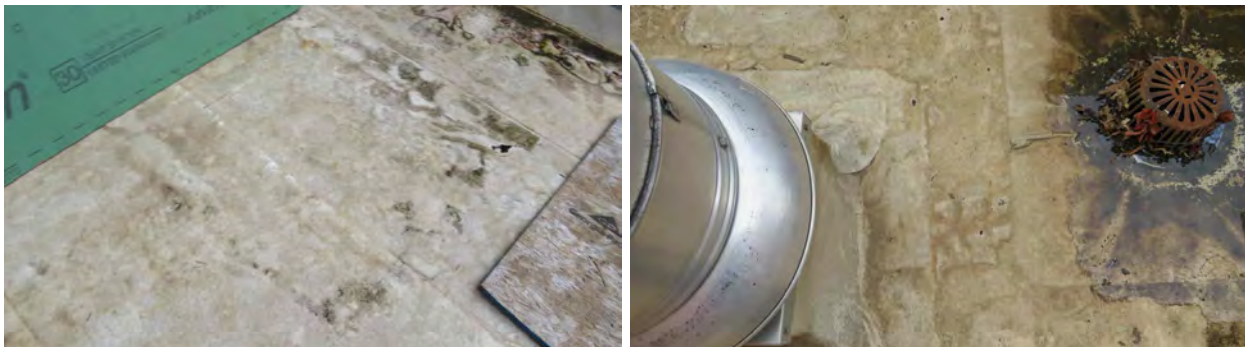
*Figure 41. Roofing on the student center (13) with no hail damage.*

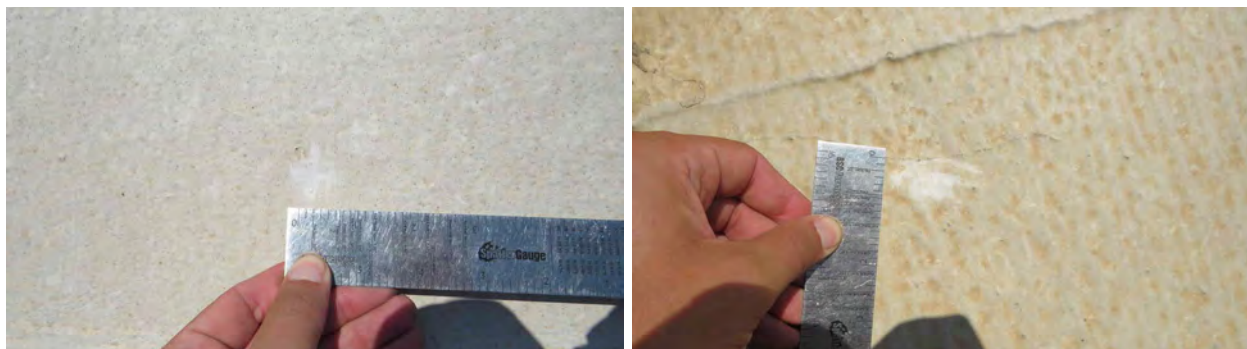
Figure 43. Roofing on the Shrewmaker center for workforce tech (12) with no hail damage.

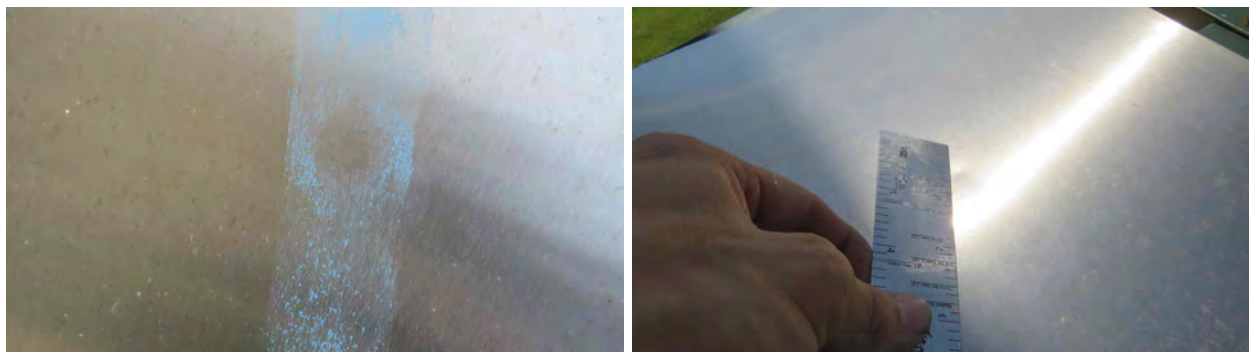
**Formed Metal Roofing (Various Roof Areas):** BSC's inspection revealed patterned indentations with no perforations or tears on various formed metal panel roof areas consistent with hail impacts. The hail impact-related conditions were consistent with the size and distribution of hail evidence documented at the subject property, associated with the reported event. The extent of hail-related conditions is detailed in the *SAM Q-PDF*<sup>®</sup> documents herein and within the attached Appendices. It is BSC's professional opinion that hail-related conditions consistent with the reported event had been documented on the various formed metal panel roof areas.

*Figure 44. Roofing on the bob burns hall (1) with hail-related conditions.*

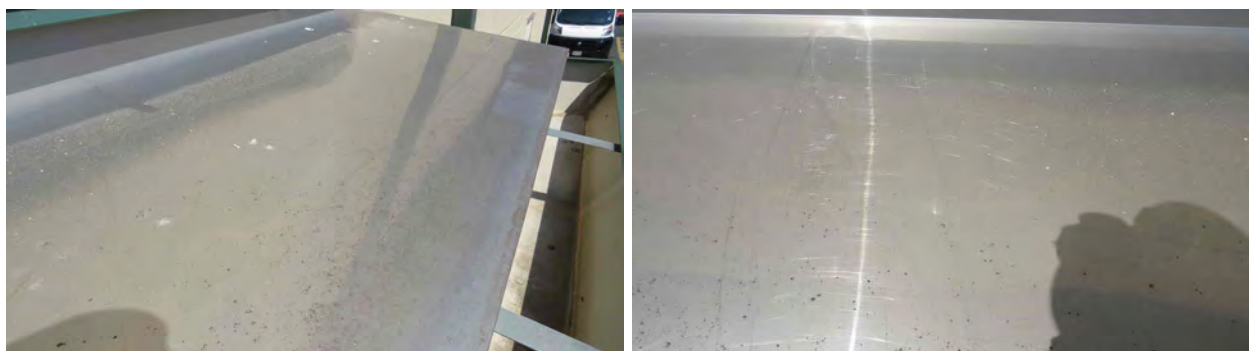
*Figure 45. Roofing on the bob burns hall (1) with no hail damage.*

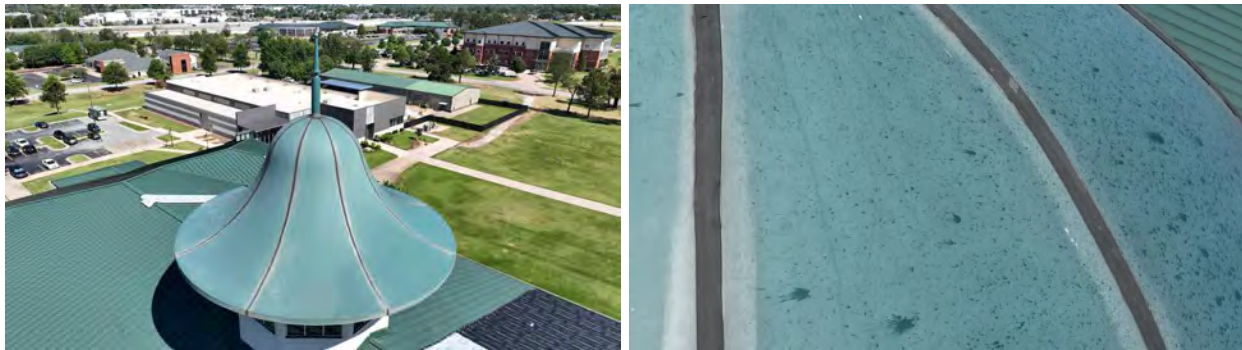
Figure 46. Roofing on the student center (13) with no hail damage.

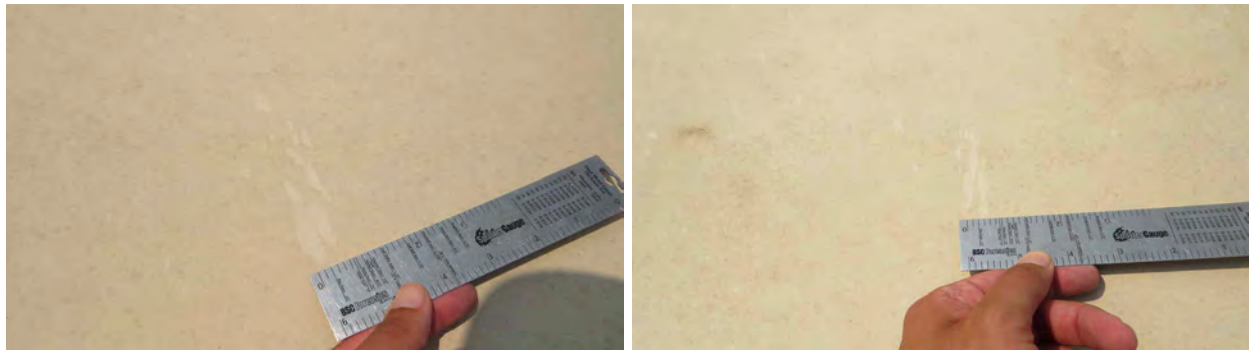
**Thermoplastic Polyolefin (TPO) Roofing (Various Roof Areas):** BSC's inspection revealed no roughly circular fractures in the TPO roofing consistent with hail impacts. Patterned spatter marks were evident with no distress conditions. It is BSC's professional opinion that the thermoplastic

polyolefin (TPO) roofing had not been damaged by hail impacts from the reported event or any event.

*Figure 48. Roofing on the integrated design lab (6) with no hail damage.*

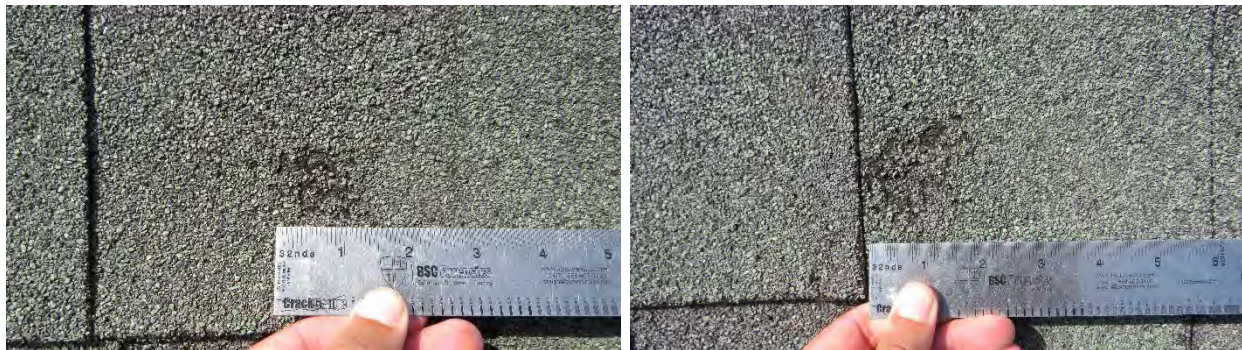
**Asphalt-Composition Shingles (Various Roof Areas):** BSC’s inspection revealed patterned roughly circular areas of exposed asphalt with corresponding depressions and/or fractures that were consistent with hail impacts. The hail impact-related conditions were consistent with the size and distribution of hail evidence documented at the subject property, associated with the reported event. The extent of hail-related conditions is detailed in the *SAM Q-PDF*<sup>®</sup> documents herein and within the attached Appendices. It is BSC’s professional opinion that hail-related conditions associated with the report event had been documented on the various asphalt-composition shingle roof areas.

Figure 50. Roofing on the national child protection training center (8) with hail-related conditions.

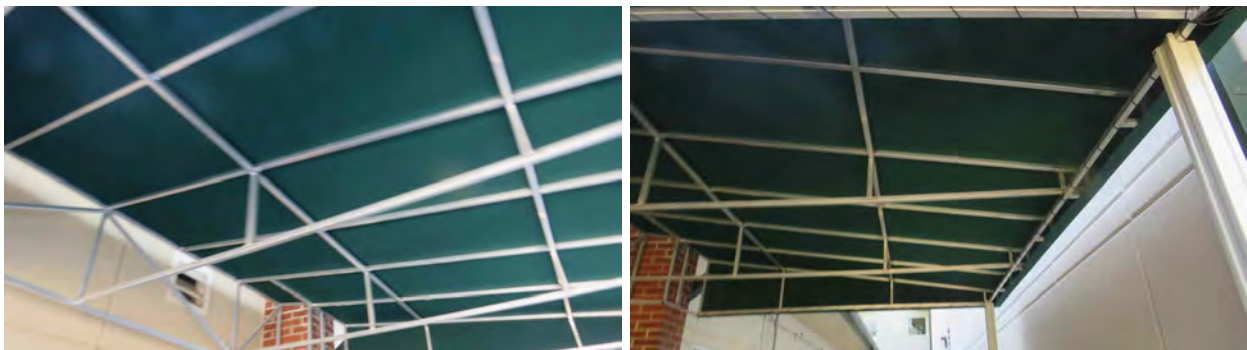
**Canvas/Fabric Roofing (Various Roof Areas):** BSC's inspection revealed no patterned or roughly circular tears in the fabric canopy roofing consistent with hail impacts. It is BSC's professional opinion that the fabric canopy roofing on the various roof areas had not been damaged by hail impacts from the reported event or any event.

*Figure 52. Roofing on the Bob Burns hall (1) with no hail damage.*

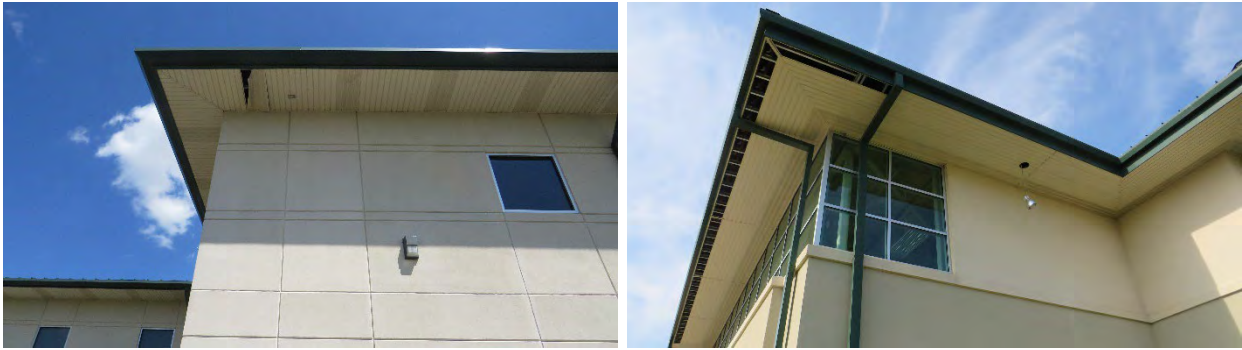
**The Campus (Date of Loss):** BSC's inspection revealed and/or historical aerial images captured both one (1) and two (2) days following the event depicted conditions along the various elevations at the subject campus that were attributable to wind from the reported event. Specifically, conditions along the various elevations associated with the reported event are detailed in the *Rough-Order Scope* section herein. It is BSC's professional opinion that evidence of wind, including wind-related distress conditions detailed herein, associated with the reported event had been documented at the subject campus.

*Figure 53. Vulnerable elements at the subject property with wind-related conditions consistent with the reported date of loss.*

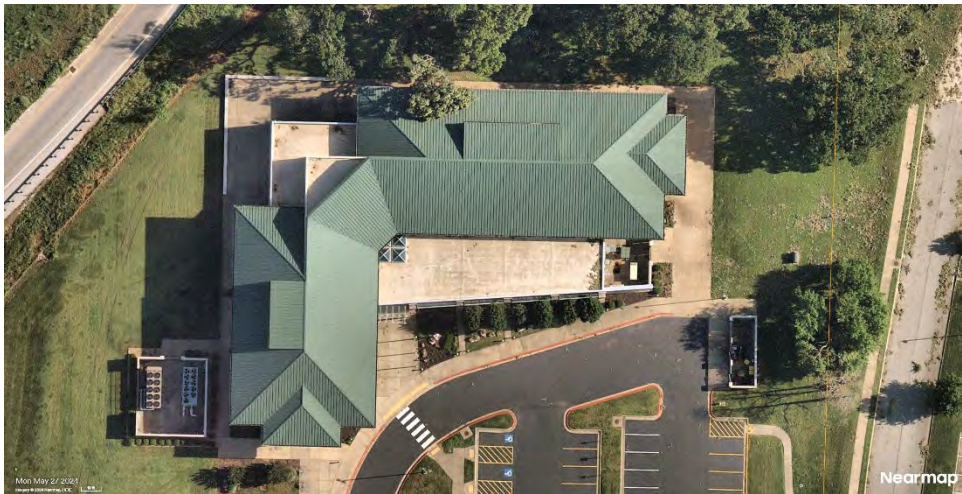
*Figure 55. Nearmap image of the shrewmaker center for workforce tach (12) captured on May 27, 2024.*

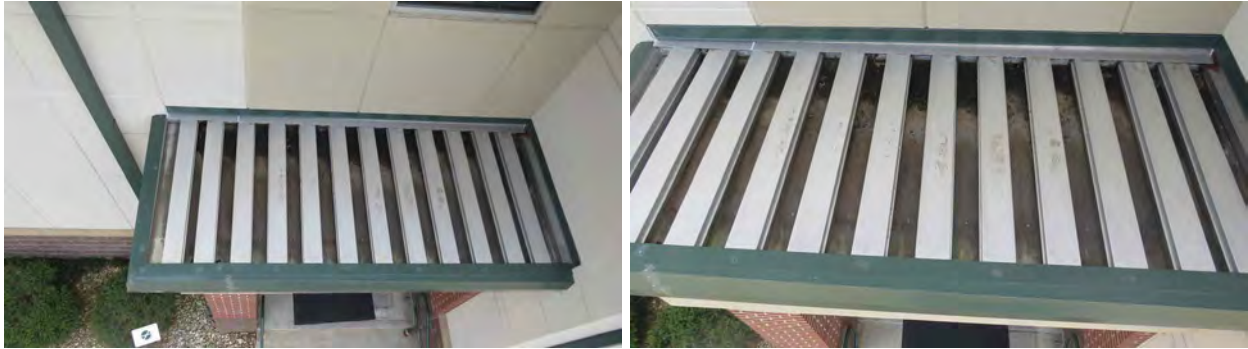
*Figure 65. Roofing on the bob burns hall (1) with no wind damage.*

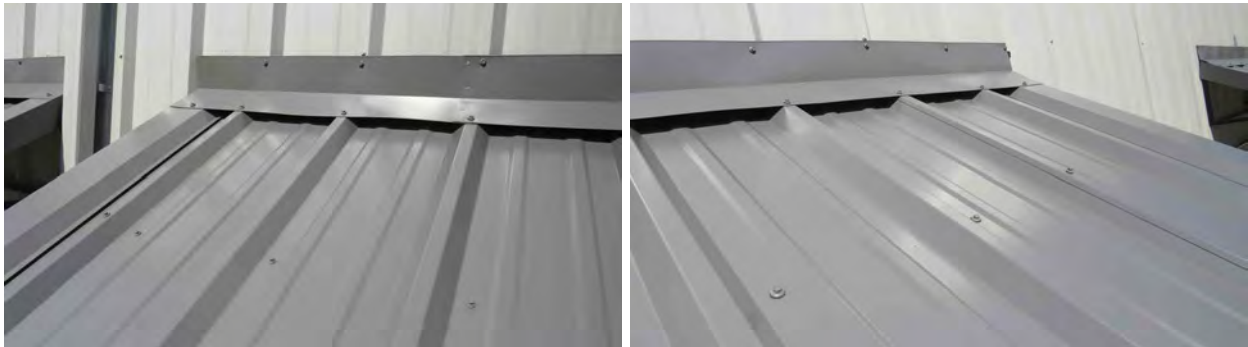
*Figure 66. Roofing on the physical plant building (10) with no wind damage.*

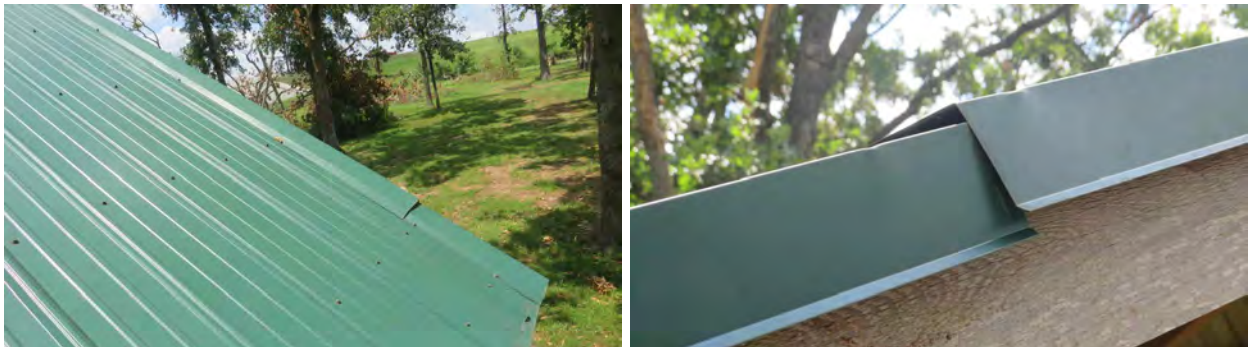
**Metal Panels (Various Roof Areas):** BSC's inspection revealed conditions consistent with the effects of wind, windborne debris impacts, and/or tree impacts during the reported event. Additionally, BSC's review of aerial images captured within one (1) and two (2) days following the event depicted various roof areas with missing and/or displaced metal panels and trees on various roof areas. The extent of wind-related conditions is detailed in the SAM Q-PDF<sup>®</sup> documents herein and within the attached Appendices. The majority of metal panel roof areas throughout the campus had not been damaged by wind. It is BSC's professional opinion that wind-related conditions consistent with the reported event had been documented on various metal panel roof areas.

*Figure 67. Roofing on the challenge course pavilion (4) with wind-related conditions.*

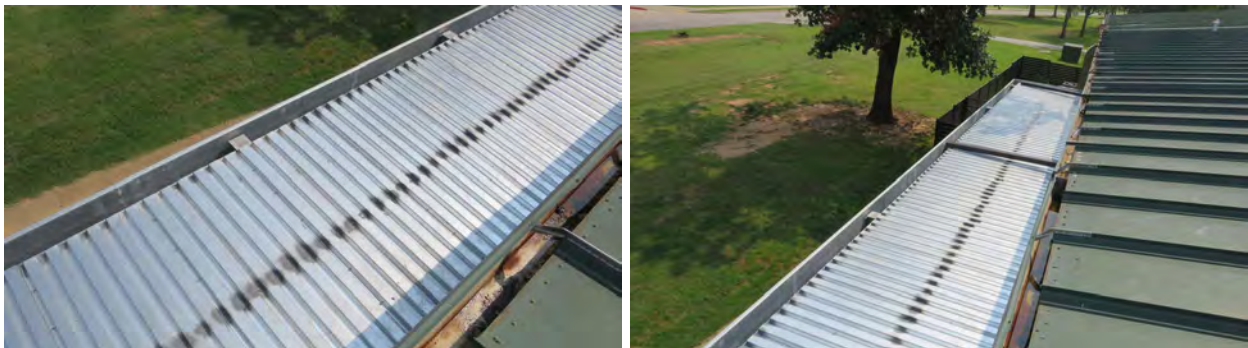
*Figure 68. Roofing on the maintenance building (7) with no wind damage.*

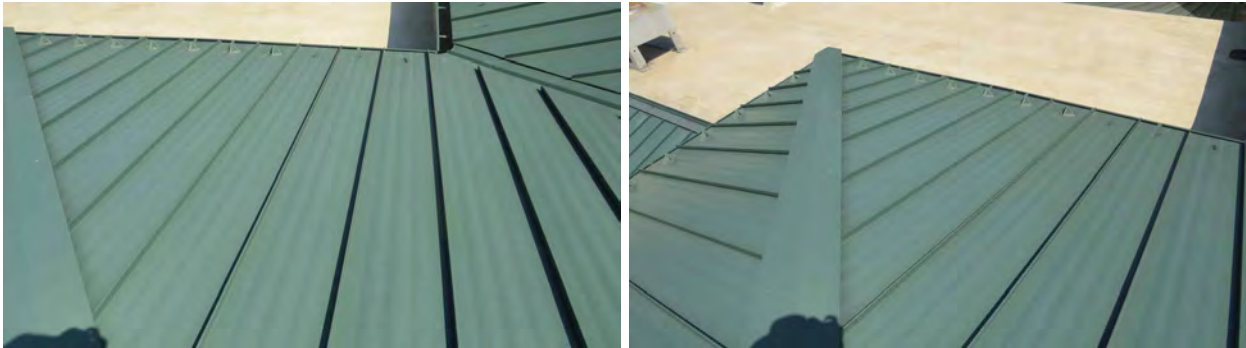
*Figure 70. Roofing on the bob burns hall (1) with no wind damage.*

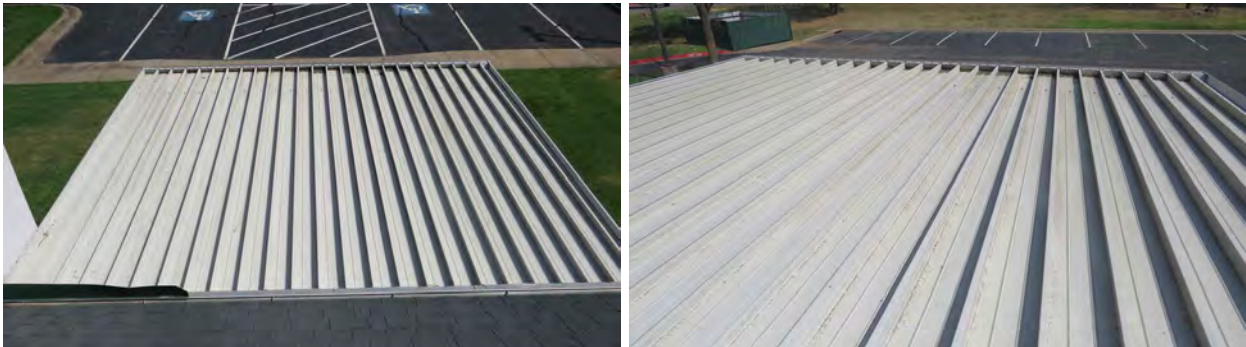
*Figure 71. Roofing on the national child protection training center (8) with no wind damage.*

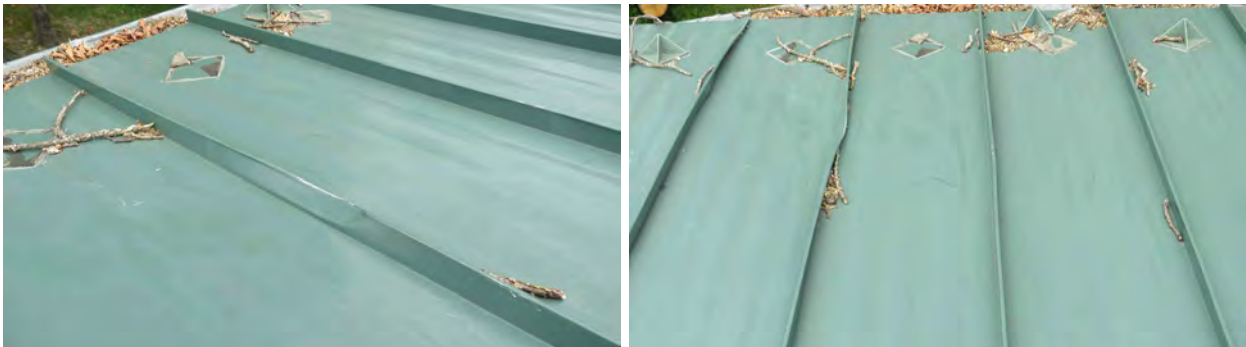
*Figure 72. Roofing on the global business development center (5) with wind-related conditions.*

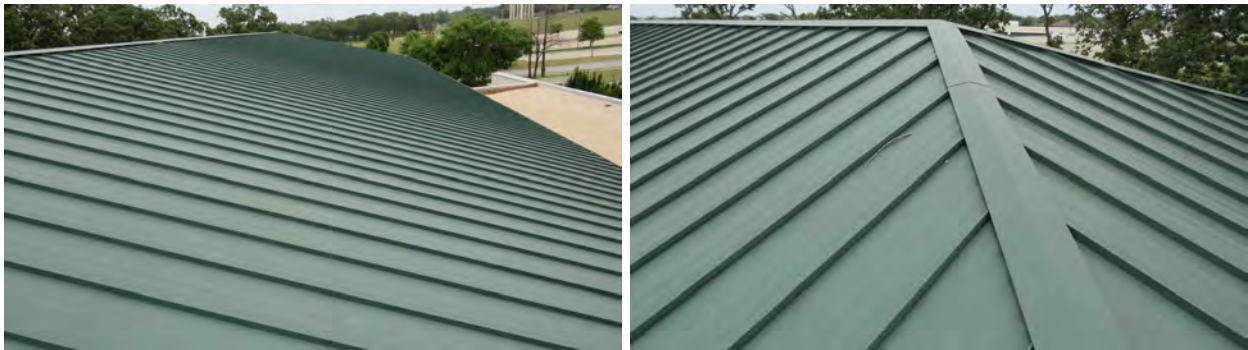
*Figure 73. Roofing on the global business development center (5) with no wind damage.*

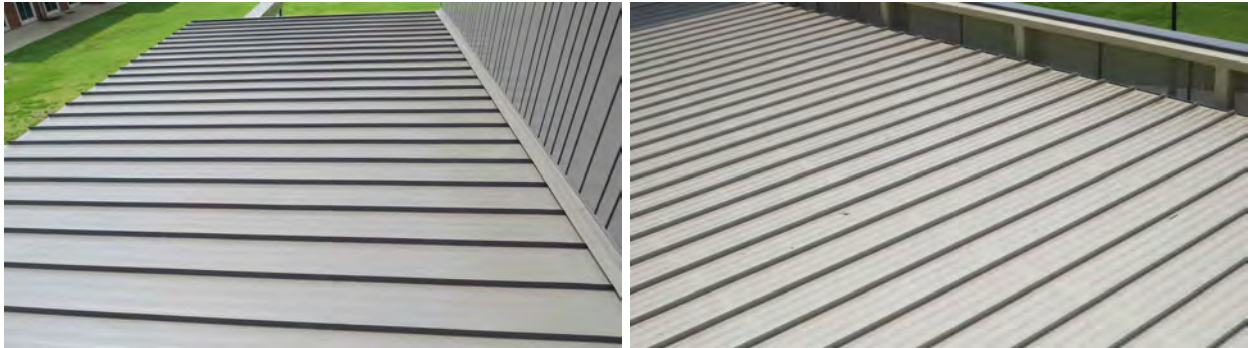
*Figure 74. Roofing on the integrated design lab (6) with no wind damage.*

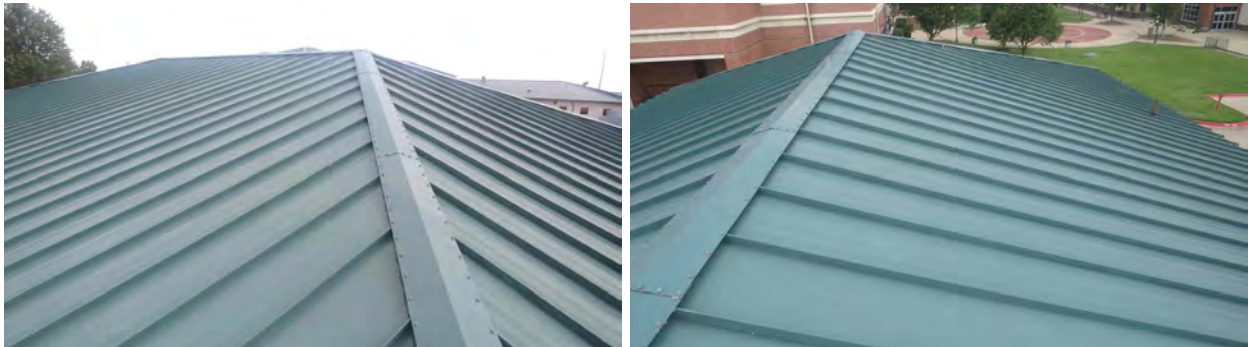
*Figure 75. Roofing on the central energy plant (3) with no wind damage.*

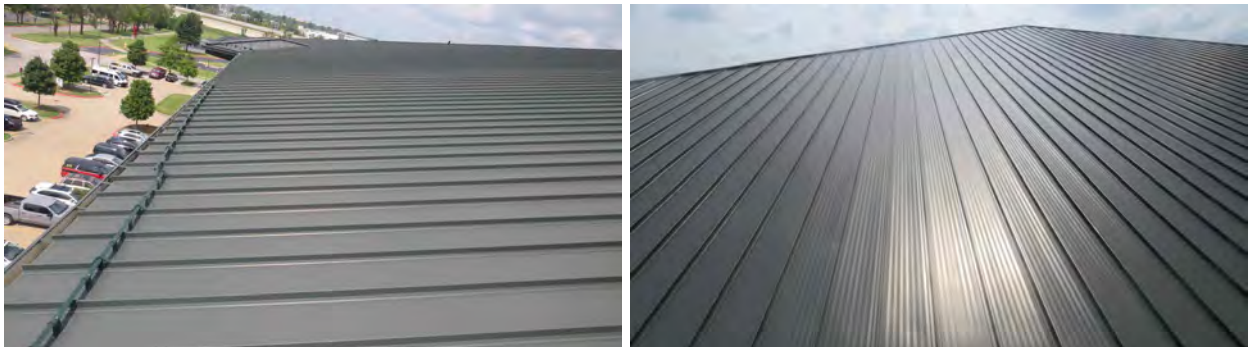
*Figure 76. Roofing on the center for health professionals (2) with no wind damage.*

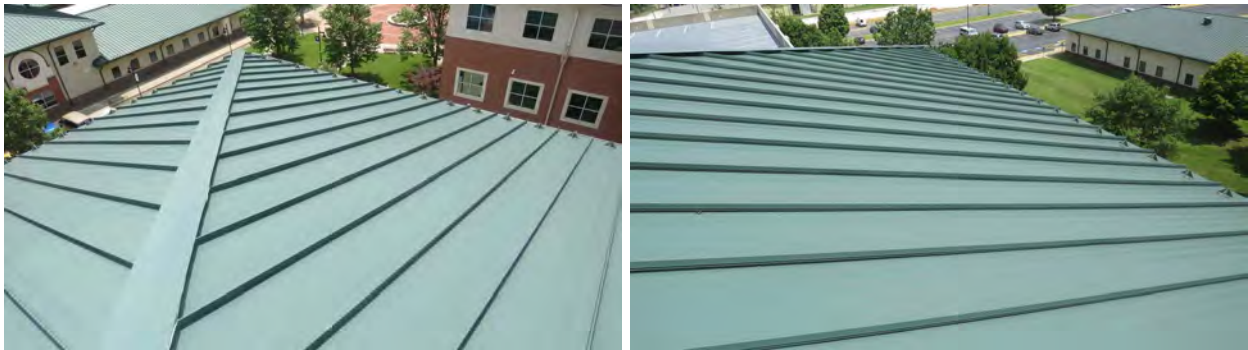
*Figure 77. Roofing on the parking structure (9) with no wind damage.*

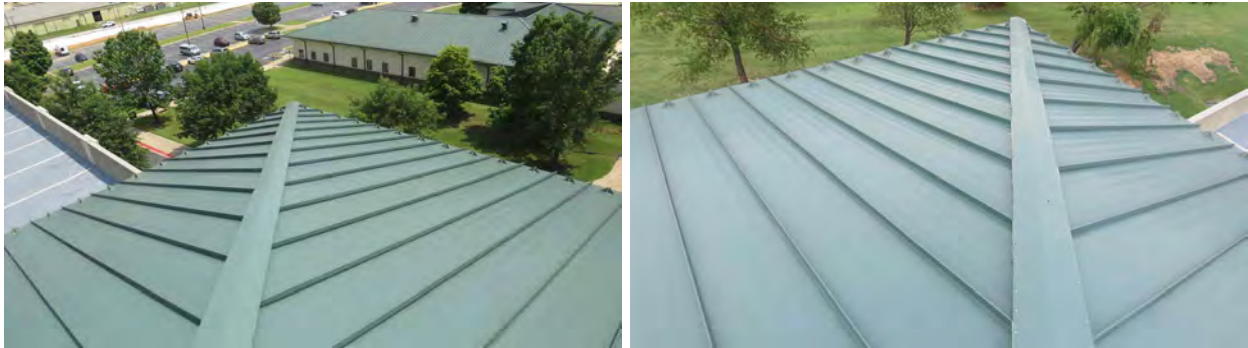
*Figure 78. Roofing on the parking structure (9) with no wind damage.*

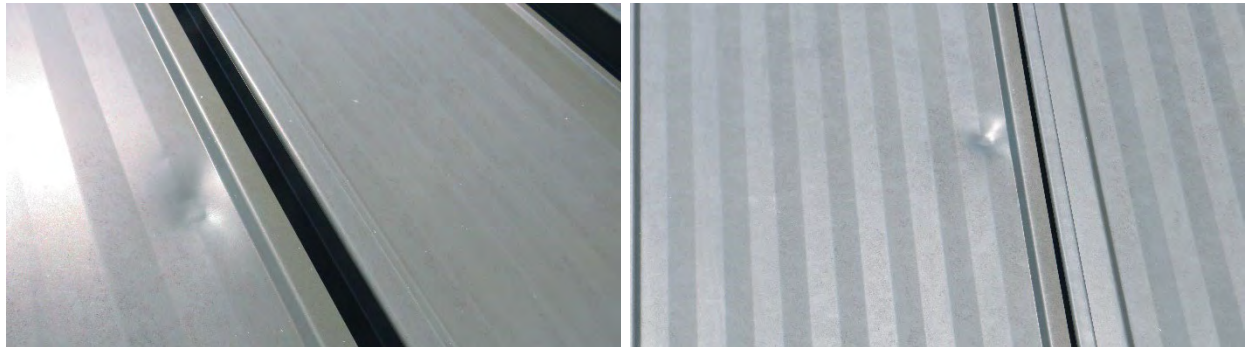
*Figure 79. Roofing on the shrewmaker center for workforce tech (12) with wind-related conditions.*

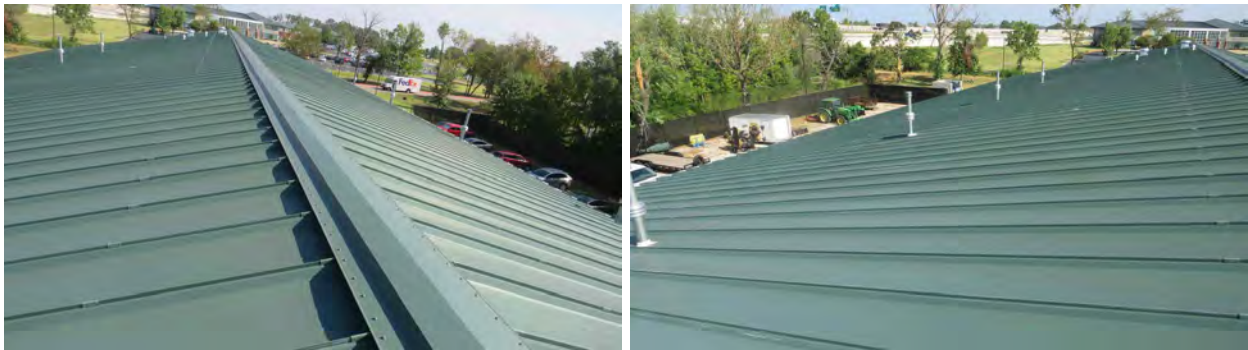
*Figure 84. Roofing on the physical plant building (10) with no wind damage.*

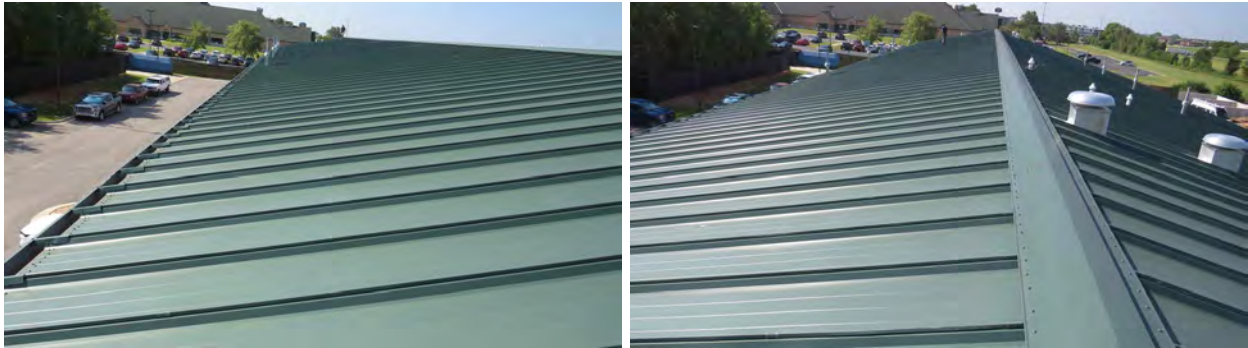
*Figure 85. Roofing on the physical plant building (10) with no wind damage.*

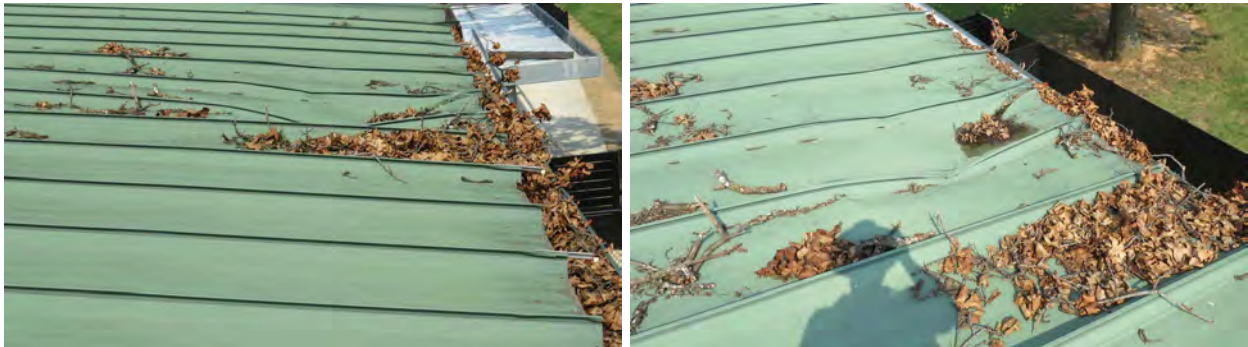
*Figure 86. Roofing on the maintenance building (7) with wind-related conditions.*

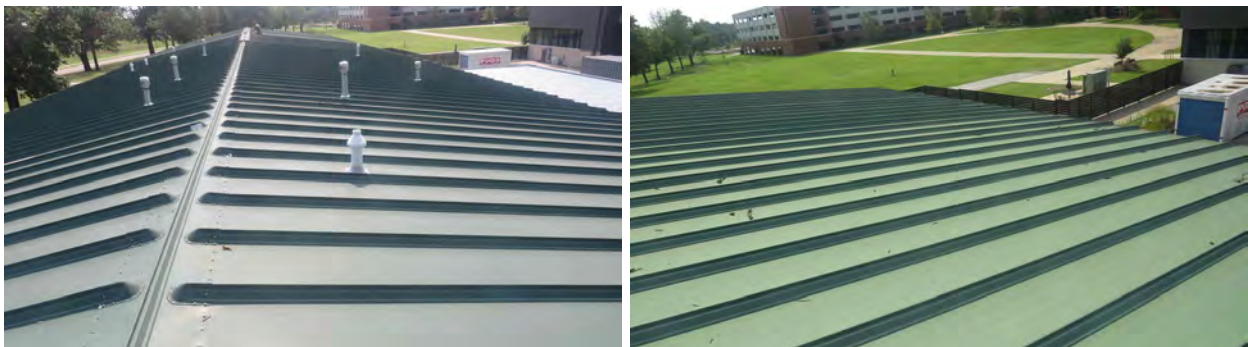
*Figure 87. Roofing on the maintenance building (7) with no wind damage.*

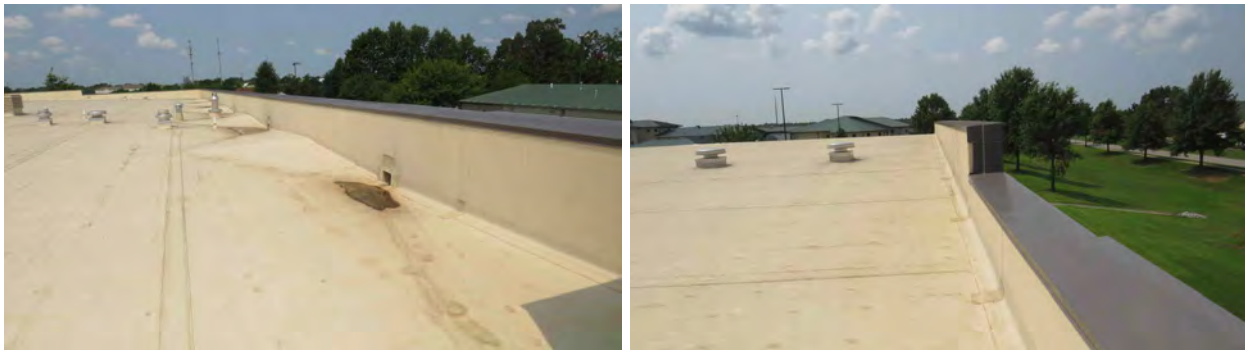
**Thermoplastic Polyolefin (TPO) Roofing (Various Roof Areas):** BSC’s inspection revealed no folded, torn, ballooned, or missing roofing and no cuts, tears, or abrasions within the membrane consistent with the effects of wind and/or windborne debris impacts. It is BSC’s professional opinion that the thermoplastic polyolefin (TPO) roofing had not been damaged by wind from the reported event or any event.

Figure 88. Roofing on the integrated design lab (6) with no wind damage.

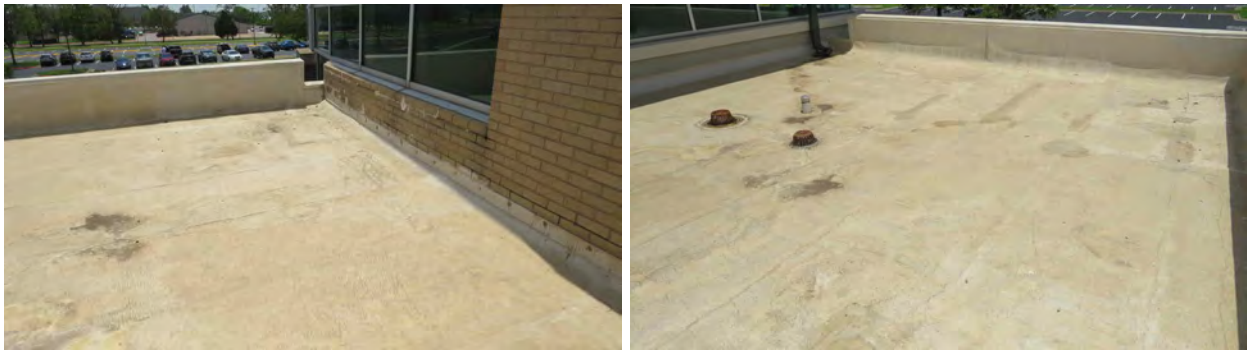
**Sealant-Coated Modified Bitumen Roofing (Various Roof Areas):** BSC’s inspection revealed no torn and/or missing roofing or any disruptions in the sealant coating consistent with windborne debris impacts on the various sealant coating modified bitumen roof areas. It is BSC’s professional opinion that the sealant-coated modified bitumen roofing had not been damaged by wind from the reported event or any event.

Figure 89. Roofing on the shrewmaker center for workforce tech (12) with no wind damage.

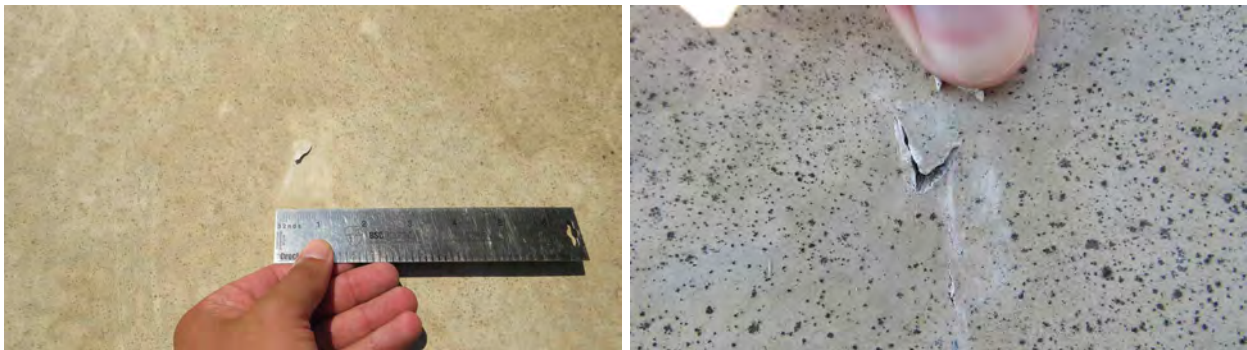
**Sealant-Coated Built-up Roofing (Various Roof Areas):** BSC's inspection revealed no torn and/or missing built-up roofing consistent with the effects of wind; however, BSC's inspection did reveal various tears, gouges, and/or abrasions in the sealant coating consistent with windborne debris impacts. The extent of wind-related conditions is detailed in the *SAM Q-PDF*<sup>®</sup> documents herein and within the attached Appendices. It is BSC's professional opinion that wind-related conditions had been documented on the various sealant-coated built-up roofing areas.

Figure 90. Roofing on the bob burns hall (1) with wind-related conditions.

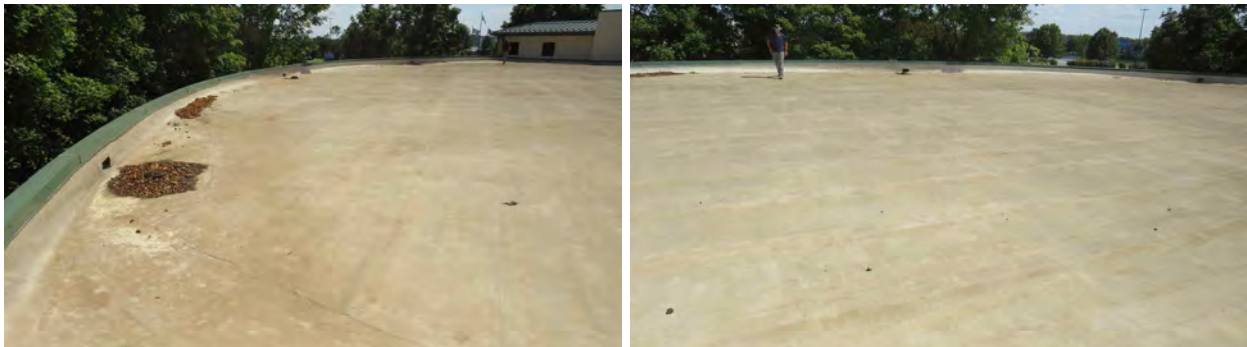
Figure 91. Roofing on the bob burns hall (1) with no wind damage.
