August 28, 2024

C.C. (Chris) Andersen  
**Central Adjustment Company, Inc.**  
Post Office Box 25068  
Little Rock, Arkansas 72221

RE: File No: **173616**  
Insured: 198 Northwest Arkansas Community College  
Address: One College Drive  
Bentonville, Arkansas 72712  
Date of Loss: May 26, 2024  
BSC File No: 240353.S-01-1

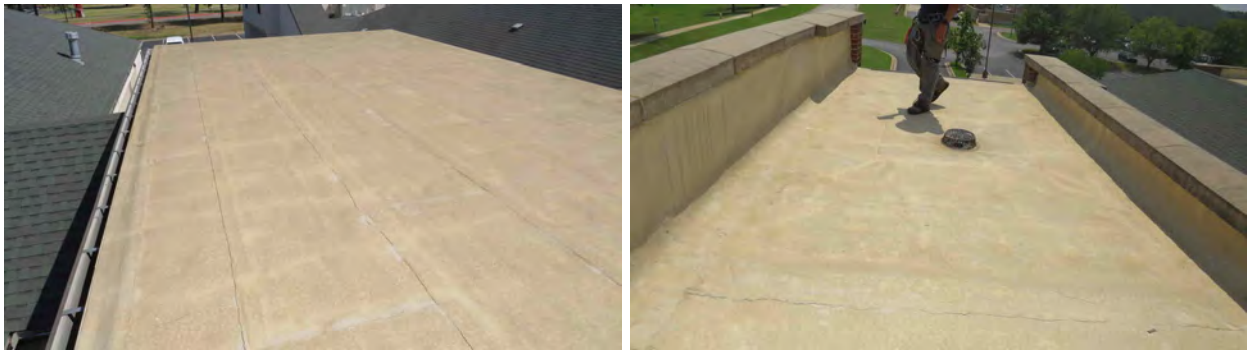
Figure 92. Roofing on the national child protection training center (8) with no wind damage.

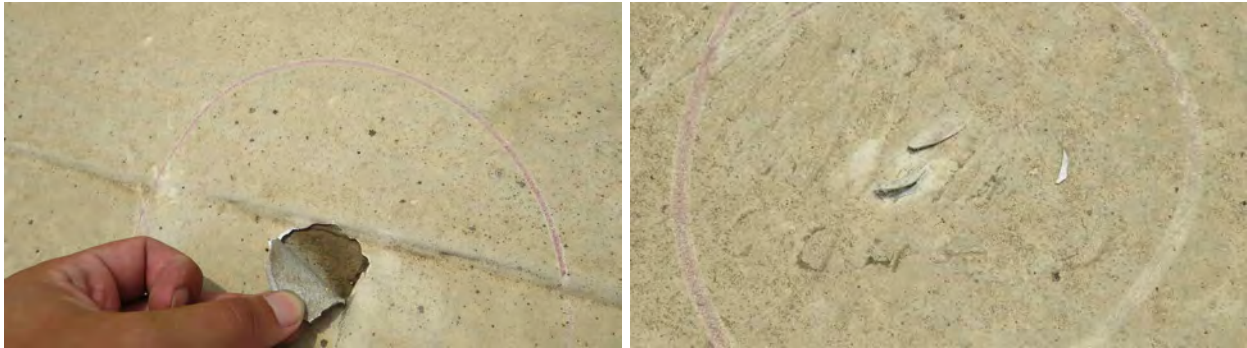
**Sealant-Coated Built-up Roofing (Various Roof Areas):** BSC's inspection revealed no torn and/or missing built-up roofing consistent with the effects of wind; however, BSC's inspection did reveal various tears, gouges, and/or abrasions in the sealant coating consistent with windborne debris impacts. The extent of wind-related conditions is detailed in the *SAM Q-PDF*<sup>®</sup> documents herein and within the attached Appendices. It is BSC's professional opinion that wind-related conditions had been documented on the various sealant-coated built-up roofing areas.

Figure 93. Roofing on the global business development center (5) with wind-related conditions.

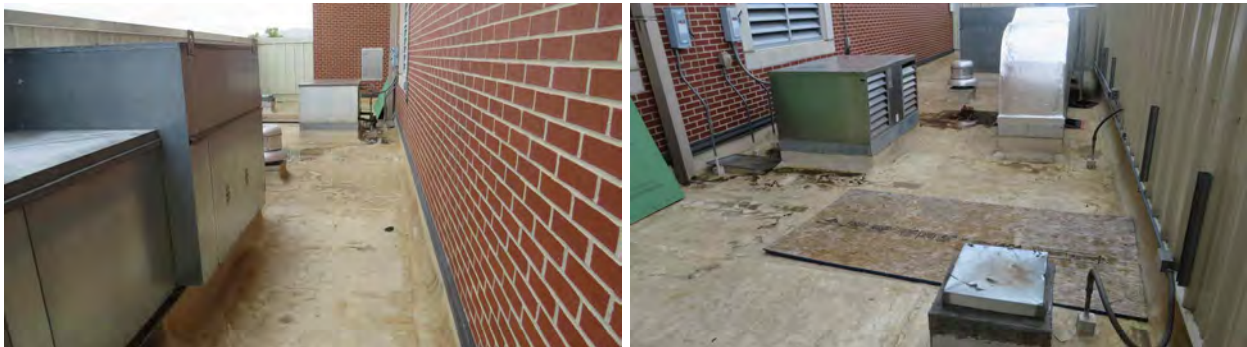
Figure 94. Roofing on the student center (13) with no wind damage.

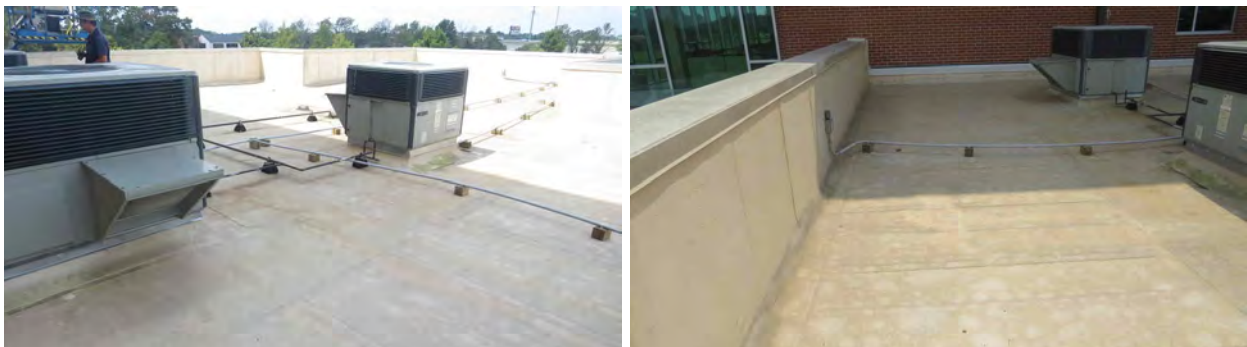
Figure 95. Roofing on the center for health professionals (2) with no wind damage.

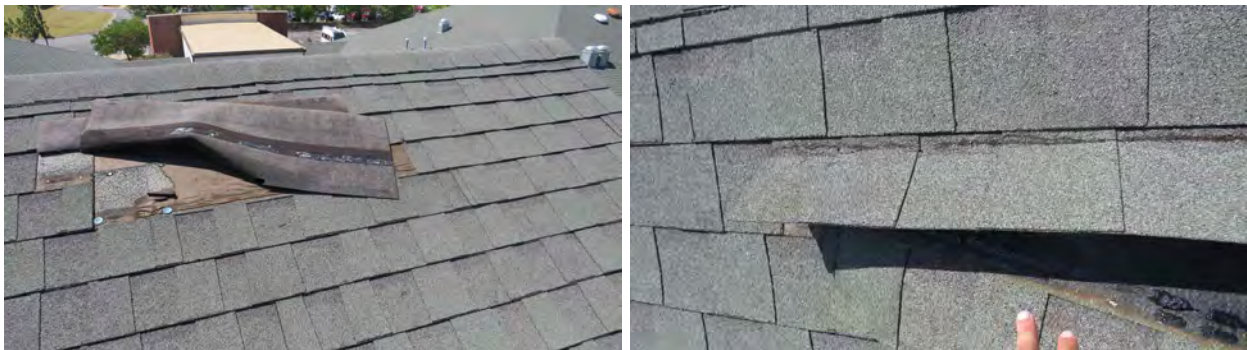
**Architectural Asphalt-Composition Shingles (Various Roof Areas):** BSC's inspection revealed limited creased and/or displaced roofing consistent with the effects of wind during the reported event. The extent of wind-related conditions is detailed in the *SAM Q-PDF*<sup>®</sup> documents herein and within the attached Appendices. It is BSC's professional opinion that limited wind-related conditions had been documented on the architectural asphalt-composition shingle roofing.

Figure 96. Roofing on the national child protection training center (8) with wind-related conditions.

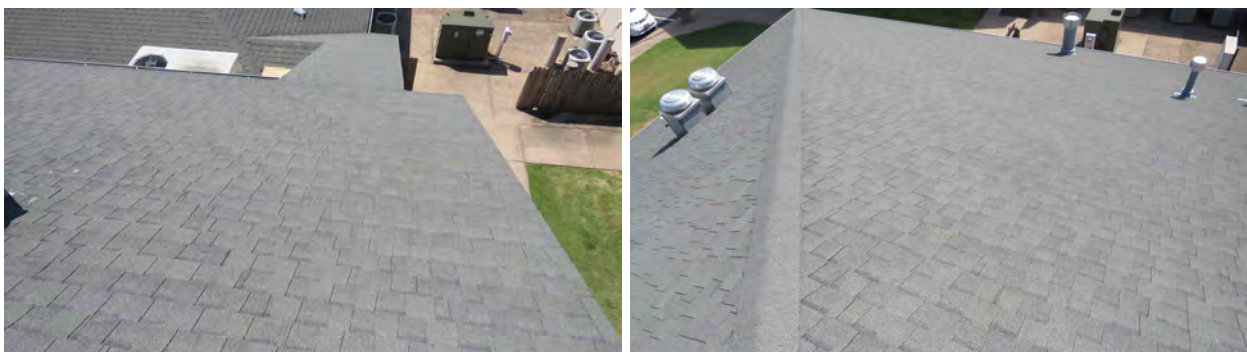
Figure 97. Roofing on the national child protection training center (8) with no wind damage.

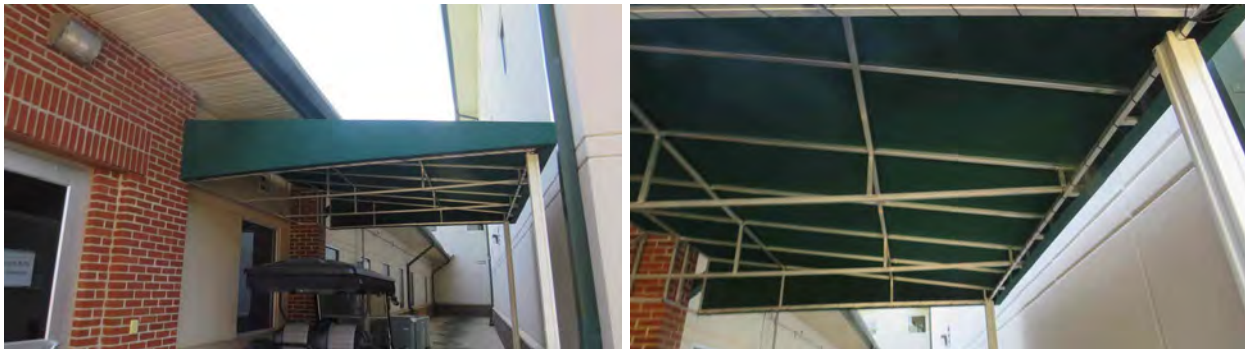
**Canopy Roofing (Various Roof Areas):** BSC's inspection revealed no torn, loose, missing, and/or punctured fabric canopy roofing consistent with the effects of wind. It is BSC's professional opinion that the fabric canopy roofing had not been damaged by wind during the reported event or any event.

Figure 98. Roofing on the Bob Burns hall (1) with no wind damage.
