August 28, 2024

C.C. (Chris) Andersen  
**Central Adjustment Company, Inc.**  
Post Office Box 25068  
Little Rock, Arkansas 72221

RE: File No: **173616**  
Insured: 198 Northwest Arkansas Community College  
Address: One College Drive  
Bentonville, Arkansas 72712  
Date of Loss: May 26, 2024  
BSC File No: 240353.S-01-1

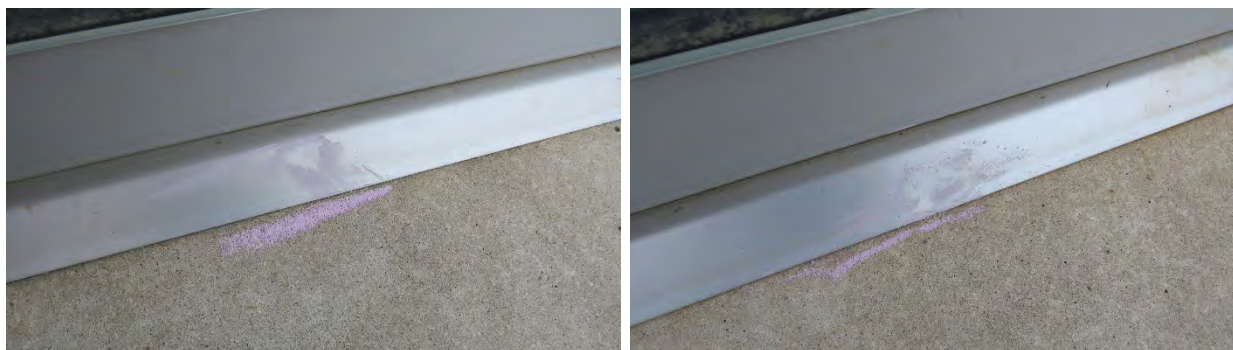
**The Campus (Historical):** BSC's inspection revealed evidence of hailfall in the form of patterned indentations in various light-gauge metal components with no perforations or tears (cosmetic) that lacked corresponding spatter marks and, as such, were associated with one (1) or more historical storm events. The evidence of historical hail-related conditions was localized to the west-facing elevations of the various structures located at the northwest corner of the campus. It is BSC's professional opinion that evidence of hailfall associated with one (1) or more historical events was documented at the subject property in the form of patterned indentations in various light-gauge metal components with no perforations or tears (cosmetic).

Figure 2. Vulnerable elements with evidence of historical hailfall.

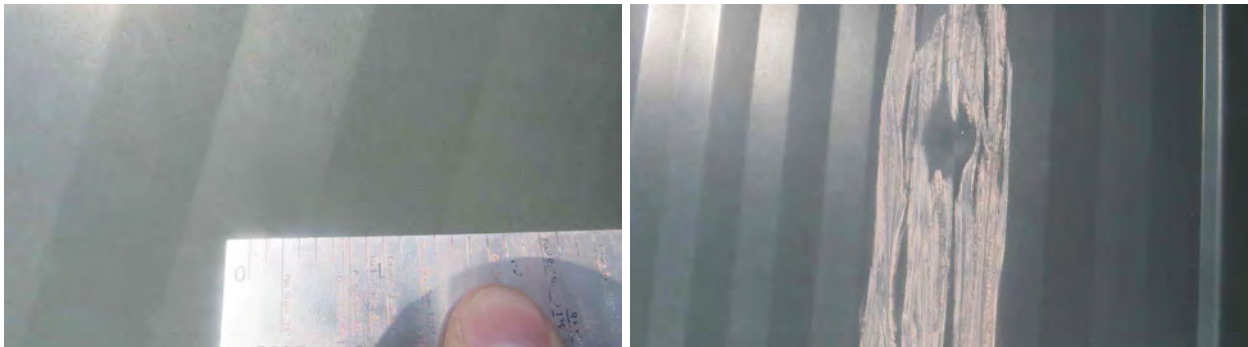
**Metal Panels (Various Roof Areas):** BSC's inspection revealed relatively widespread patterned indentations with no perforations, tears, or disengaged seams/overlaps (cosmetic) consistent with hail impacts. The size, distribution, and directional manifestation of the hail-related conditions were primarily consistent with hail impacts during the reported event; however, various roof areas detailed herein also exhibited historical hail-related cosmetic indentations. The hail impact-related conditions were consistent with the size and distribution of hail evidence documented at the subject property, associated with both the reported event and one (1) or more historical events. The extent of hail-related roofing conditions are detailed in the *SAM Q-PDF*<sup>®</sup> documents herein and within the attached Appendices. It is BSC's professional opinion that hail-related conditions consistent with both the reported event and one (1) or more historical event(s) had been documented along the various metal panel roof areas at the subject campus.

*Figure 16. Roofing on the center for health professionals (2) with hail-related conditions.*
